Technical Service Bulletin

15 Engine: Cylinder head cover - oil residue Q5 (inline 4-cyl., 2.0 ltr. TFSI)

15 24 49 2072716/2 May 16, 2024. Supersedes Technical Service Bulletin Group 15 number 24-47 dated January 18, 2024 for reasons listed below.

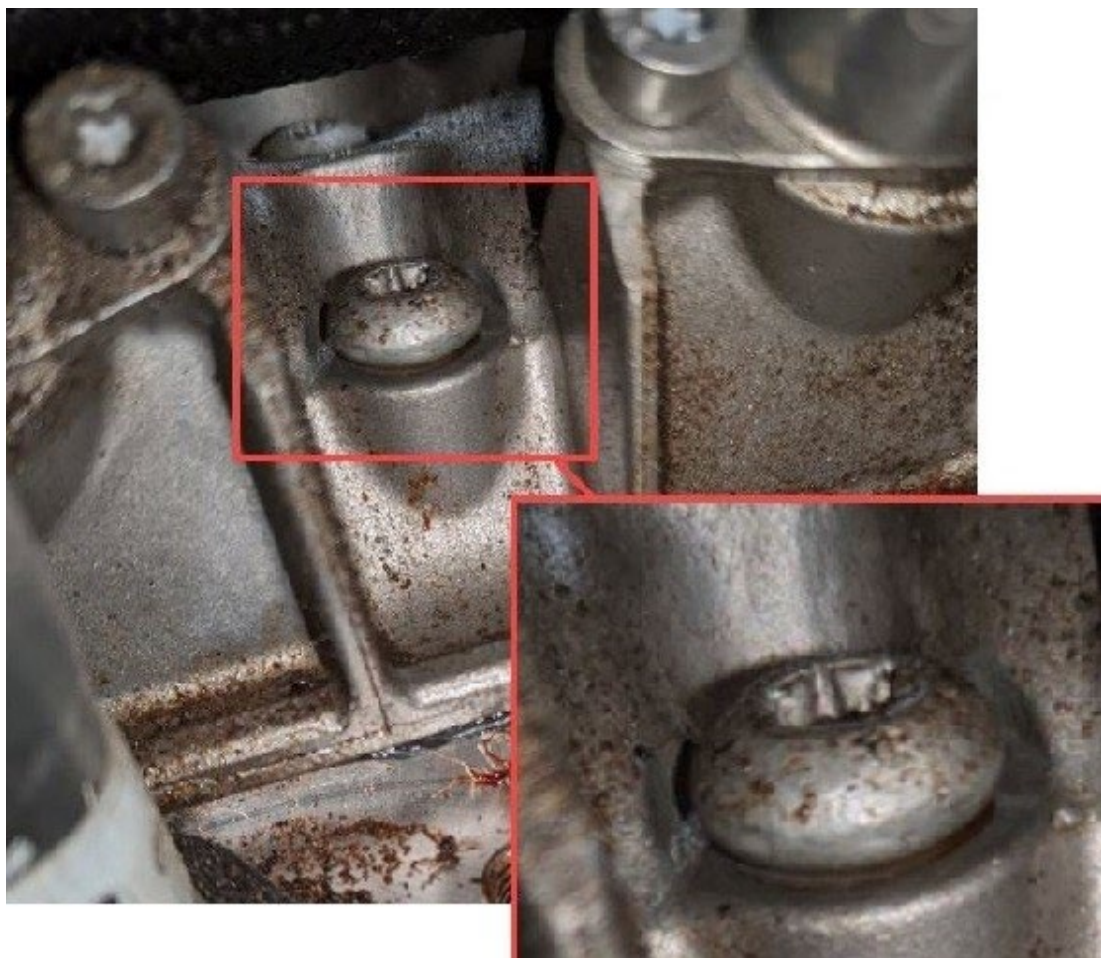
- The cylinder head cover is leaking in the area around the threaded connection on one or multiple bolts (Figure 1).

Figure 1: Oil on the threaded connection.

In cases, burrs on the cylinder head cover bolts can cause the bolts to become loose. This can cause oil residue in the area around the threaded connection.

Burrs in the screw are caused in the threading process. Adjustment and verification of the tool for material feeding by screw supplier.

- Please replace the affected bolt(s).

- Please ensure that replacing the bolts remedies the leaking.
