Technical Service Bulletin

93 "Electrical system: Malfunction! Safely turn off vehicle" is in the cluster, DTC P0AC000 is stored in battery module

93 24 56 2059309/6 May 16, 2024. Supersedes Technical Service Bulletin Group 93 number 23-18 dated August 10, 2023 for reasons listed below.

Model(s)	Year	VIN Range	Vehicle-Specific Equipment
Q5 e quattro	2019 - 2021	All	PHEV
A7 e quattro	2021

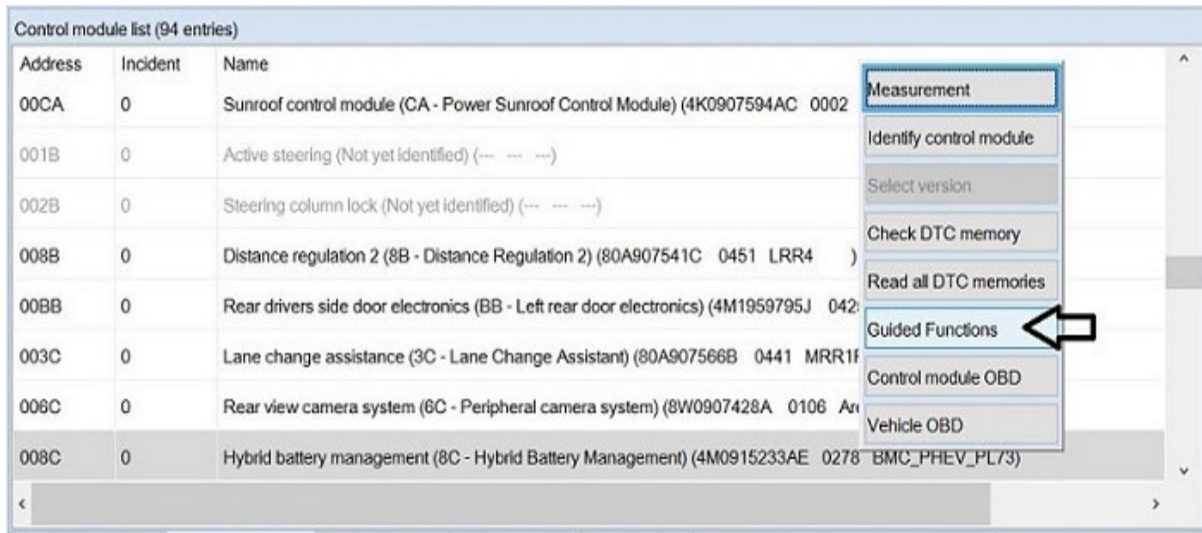
Figure 2. Guided Functions.

- 1 To obtain the data we need to use the diagnostic scan tool then right-click and select the hybrid battery management module, J840 (address word 008C), and select “Guided Functions” (Figure 2).

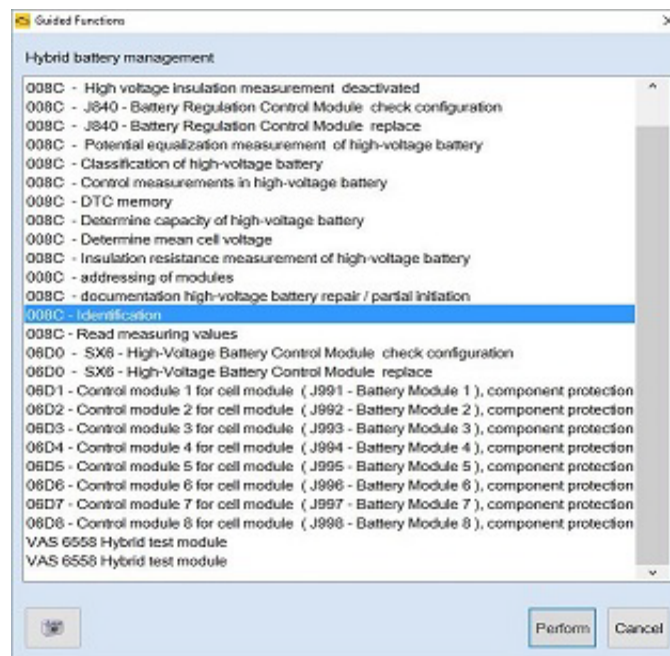
Figure 3. Guided Functions Menu.

- 2 In the Guided Functions menu select 008C – Identification and click “Perform” (Figure 3).
