# Service Bulletin

Bulletin No.: 24-NA-099

**Subject: Clunking Noise from Front of Vehicle**

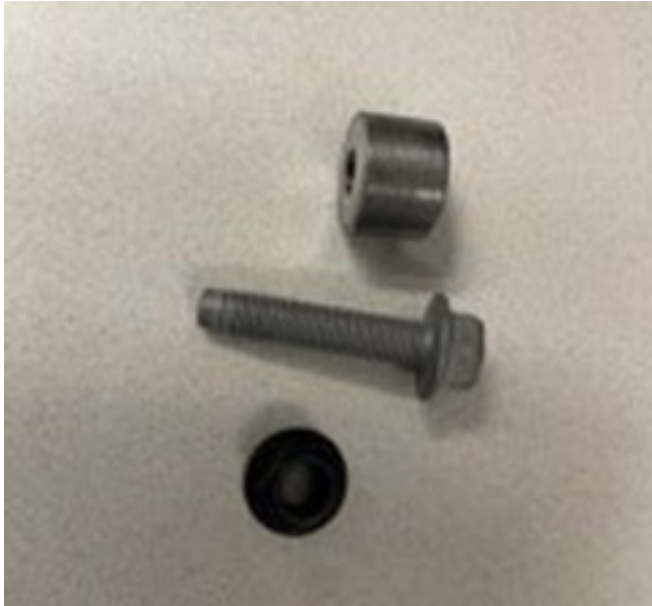
<b>Involved Region or Country</b>	North America, Europe, Kazakhstan, Uzbekistan, Russia, Middle East, Iraq, Israel, Palestine, Argentina (Mercosur), Brazil (Mercosur), Bolivia (West), Chile (West), Colombia (West), Ecuador (West), Paraguay (West), Peru (West), Uruguay (West), Venezuela (West), Other Central America, Japan, Cadillac Korea (South Korea), GM Korea Company, China - SGM, Taiwan, Thailand (ASEAN), Singapore, Philippines, Australia/New Zealand, Caribbean
<b>Condition</b>	Some customers may comment of a clunk noise coming from the front end of the vehicle.
<b>Cause</b>	This condition may be caused by the stabilizer bar retaining nut has come loose from weld internally in the frame.
<b>Correction</b>	<div style="text-align: center;">

</div> <p style="text-align: right; font-size: small;">6664288</p> <p>Replace affected nut with special retaining bolt, spacer, and bolt. Refer to the Service Procedure.</p>
