06/21/2024  
CAL WS 54-007

**Subject: Battery Cable Depopulation Stud  
Inspection, with or without Jumpstart Post**

**Make:** Western Star

**Model:** 47X, 49X

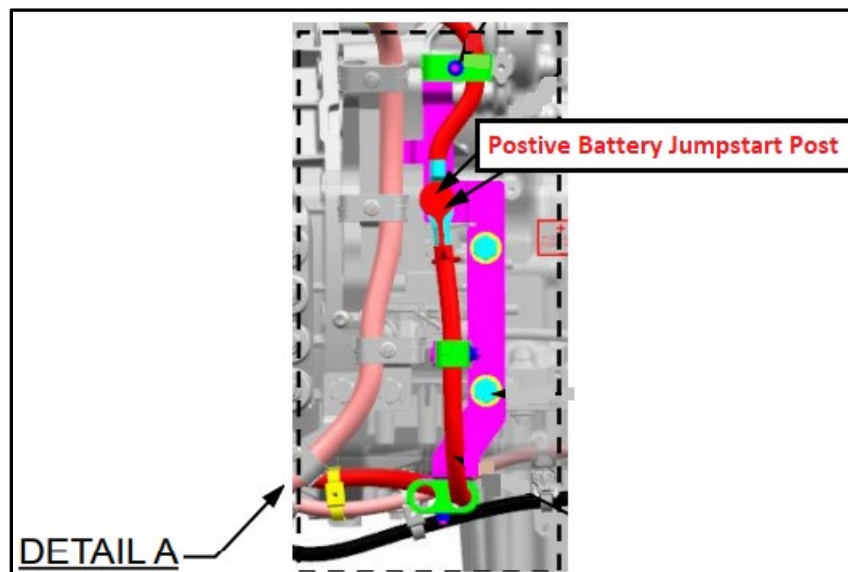
**Fig. 1, Positive Battery Jumpstart Post**

1. Park the vehicle, shut down the engine, and apply the parking brakes. Chock the tires.
2. See the installation drawing (D66-24521-001) for the location of the positive battery jumpstart post on the right-side frame rail. Note detail "A." See **Fig. 1**.
