STAR ONLINE PUBLICATION

Case Number: S2408000067

Symptom/Vehicle Issue: The Electronic Vehicle Information Center (EVIC) Displays Park Assist System Disabled Message

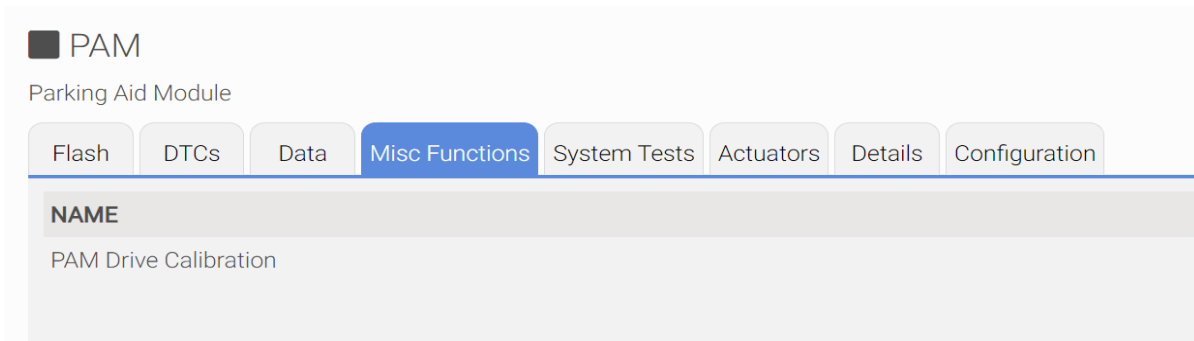
Technician Observation: The technician observed the park assist module is setting Diagnostic Trouble Code (DTC) B210C-16 Battery Voltage Input – Circuit Voltage Below Threshold after a recent repair for low battery condition.

NOTE: After Battery Drain/Low condition the “PAM” may set this code and no longer operate until the code is cleared, and the module is reset.

Repair Procedure: Reset the Park Assist/Aid Module (PAM) prior to any repair attempts or replacement of any components.

1. Connect wiTECH to the vehicle.
2. Check for active DTCs set against PAM.
3. If battery low DTC B210C-16 was set against the PAM, reset the module via wiTECH tool.

Properly charge the battery as required.

Perform a module reset.

Clear any DTC and proxi align as needed.

Perform a PAM drive calibration and verify proper operation.
