TECHNICAL SERVICE BULLETIN

Classification: KS13-051E	Reference: ITB13-052E	Date: May 20, 2024
------------------------------	--------------------------	-----------------------

INTELLIGENT KEY NOT DETECTED / ENGINE WILL NOT START

APPLIED VEHICLES: All Infiniti vehicles equipped with Intelligent Key except 2022-2024 QX60 (L51)

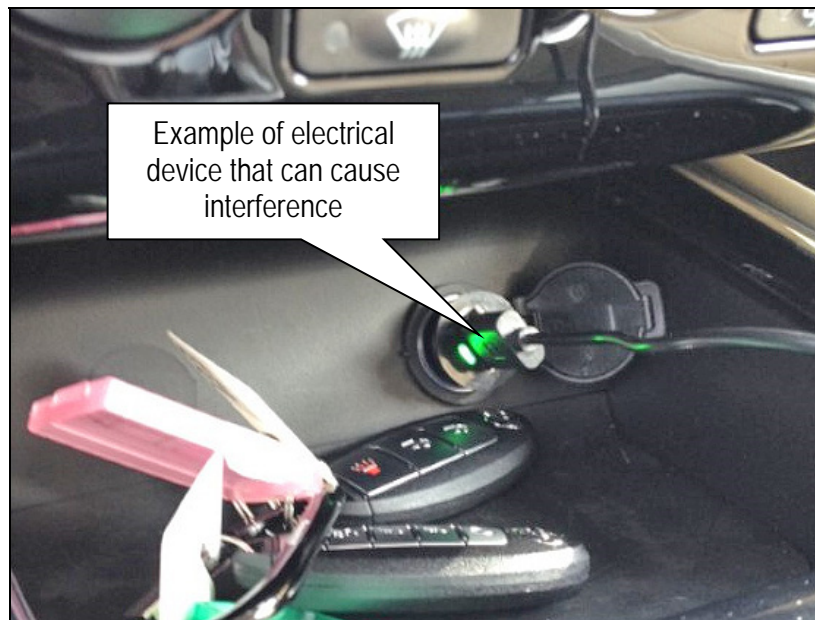
Figure 1

- Interference from other personal devices:
 - Confirm the Intelligent Key is not placed in close proximity to phones, other Intelligent Keys, highway PASS Card, USB charger, Personal Computer (PC) charger, etc. that may be transmitting similar RF signals.

- Technician should remove all devices from vehicle while diagnosing/duplicating the client's issue.
