WORK DESCRIPTION FOR FIELD MEASURE

Code: 24P7590001

Check laser solder seam on trunk lid for cracks; rework if necessary

Model 236

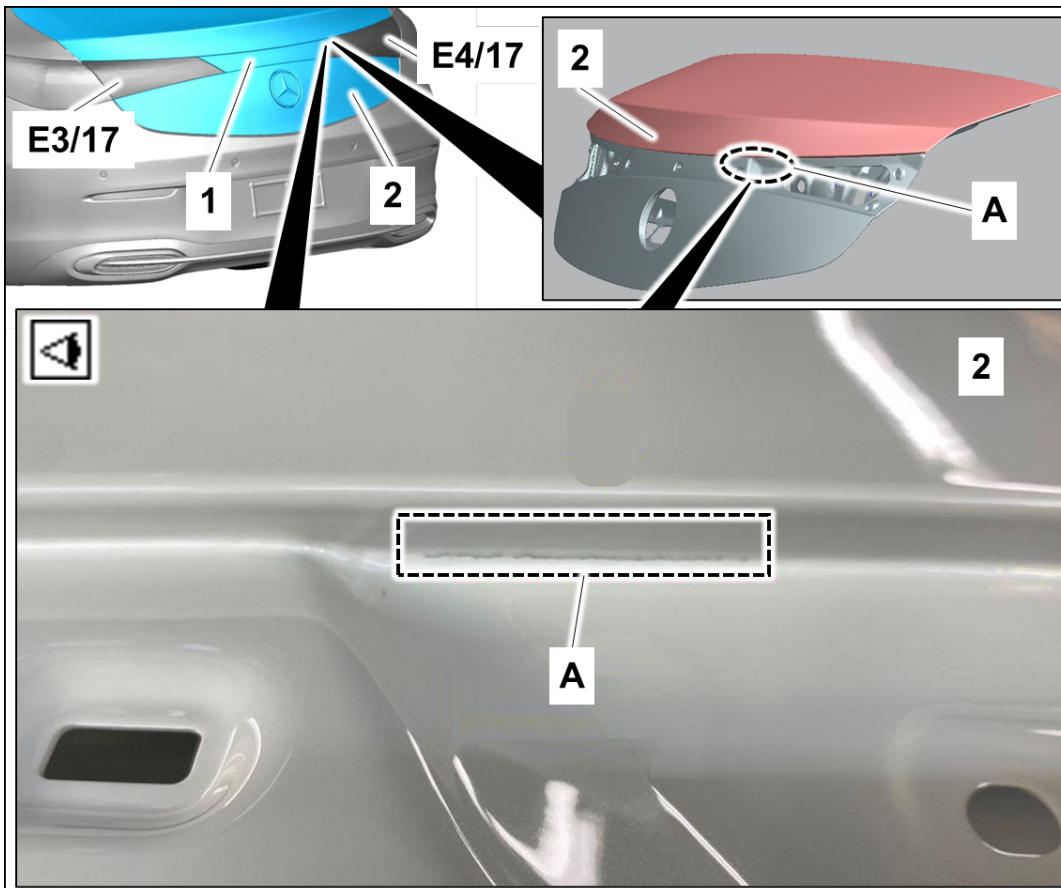
Figure 1

1. Remove left rear inner lamp unit (E3/17, Figure 1) and right rear inner lamp unit (E4/17, Figure 1).
i For basic information, see **AR82.10-P-4927WEC**.
2. Remove the trim element (1, Figure 1) from the trunk lid (2, Figure 1).
i **Installation:** The trim element (1, Figure 1) is destroyed when you remove it and a new one has to be installed in its place.
3. Check the laser solder seam (area A, Figure 1) on the trunk lid (2, Figure 1) for cracks.
i Use a flashlight here to inspect for cracks.

- a. If the laser solder seam is cracked (A, Figure 1): Perform the necessary **Work Procedure**.
- b. If the laser solder seam is **not** cracked (A, Figure 1): **End the measure**.

1. Clean the affected area of the laser solder seam (area A, Figure 1) on the trunk lid (2, Figure 1) over a wide area.
i For example with silicone remover.
2. Apply activator to the affected area of the laser solder seam (area A, Figure 1) on the trunk lid (2, Figure 1).
i Observe manufacturer's specifications for product!
3. Seal the affected area of the laser solder seam (area A, Figure 1) on the trunk lid (2, Figure 1) with transparent seam seal.
i Seal approx. 2 cm over the entire crack length of the laser solder seam (area A, Figure 1).
i Observe manufacturer's specifications for product!
4. Install in the reverse order.
