#### SIB 64 01 24

#### RYTHMIC DRUM NOISE HEARD FROM HVAC

This Service Information Bulletin (Revision 2) replaces SI B64 01 24 dated February 2024.

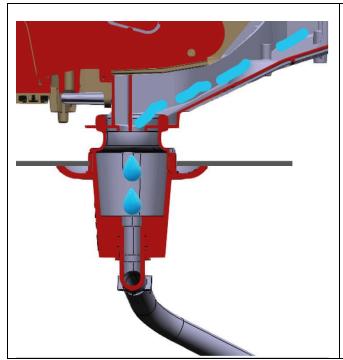
Warm temperatures combined with high air humidity may lead to the formation of condensate in the blower housing.

As a result of a high blower actuation, the formed condensate droplets are thrown vertically against the condensation drain opening at high speeds.

The resulting noise is amplified by the long condensation drainage hose, and by the geometry of the grommet and heating and air conditioning unit. These can result in an echoing effect heard from the condensate drain pipe.

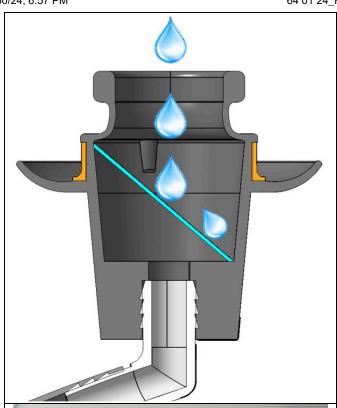
A ramp insert has been placed into the condensation drain plug, so the water drops falling into the condensate drain pipe are broken up- eliminating the drumming noise.

For vehicles produced prior to December 31, 2023, replace the condensation water drain hose assembly.

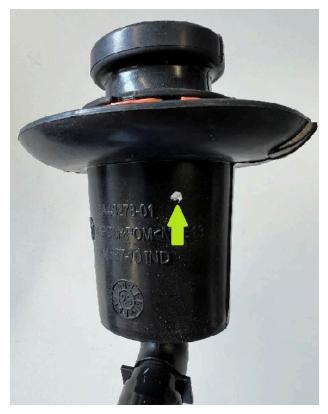
The condensation drain has been optimized and can be identified by a **WHITE DOT** or revision **INDEX 02** or higher.

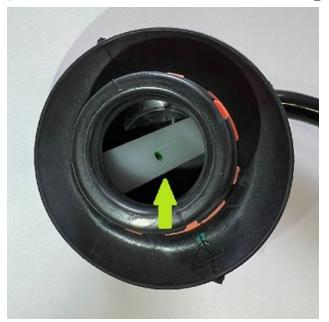
The optimized condensation drain can be identified by a ramp insert

Prior to installing new drain into body from below apply lubricant to the top of the seal (2) where it contacts the heater box.
