Field campaign

Topic	Software update for the rear door control modules - 00BB and 00BC during PDI (SC23/24)
Market area	Australia E04 Bentley rest Asia and Australia (6E04),China 723 Volkswagen (Anhui) Automotive CO (6723),China 796 VW Import Comp. Ltd (Vico), Beijing (6796),Germany E02 Bentley rest Europe (6E02),Japan E03 Bentley Japan (6E03),Korea, (South) E08 Bentley South Korea (6E08),United Arab Emirates E06 Bentley Middle East and Africa (6E06),United Kingdom E01 Bentley UK (6E01),United States E05 Bentley USA and rest America (6E05)
Brand	Bentley
Transaction No.	2071260/24
Campaign number	EC89
Note	
Type	
US code

New Continental GT and New Continental GTC

Software update to the rear door control modules 00BB and 00BC - Short drop function elimination

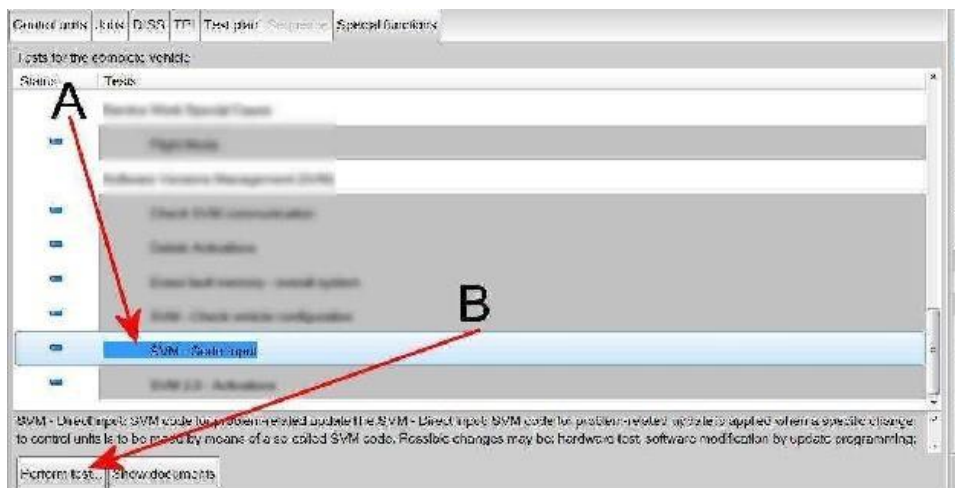
1) Referring to Figure 1 - Within the Special functions tab - Select SVM - Code Input (Point A)

- Select Perform test (Point B)

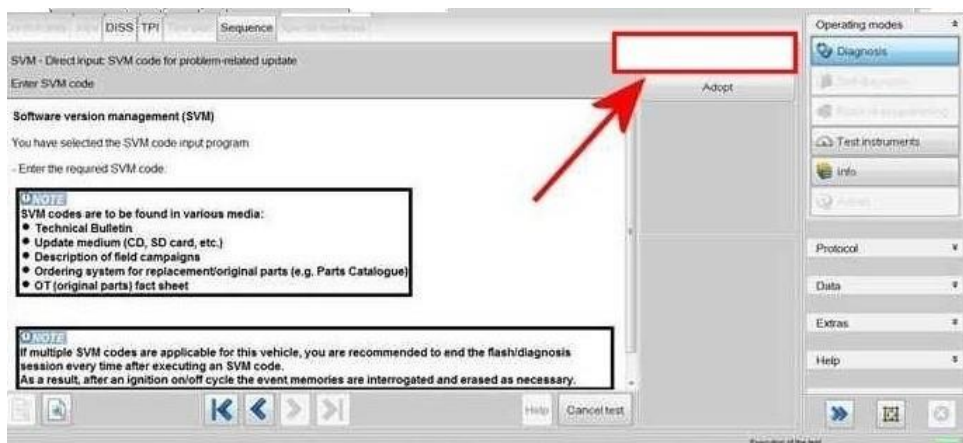
2) Referring to Figure 2 - Enter the SVM code 370WAD01

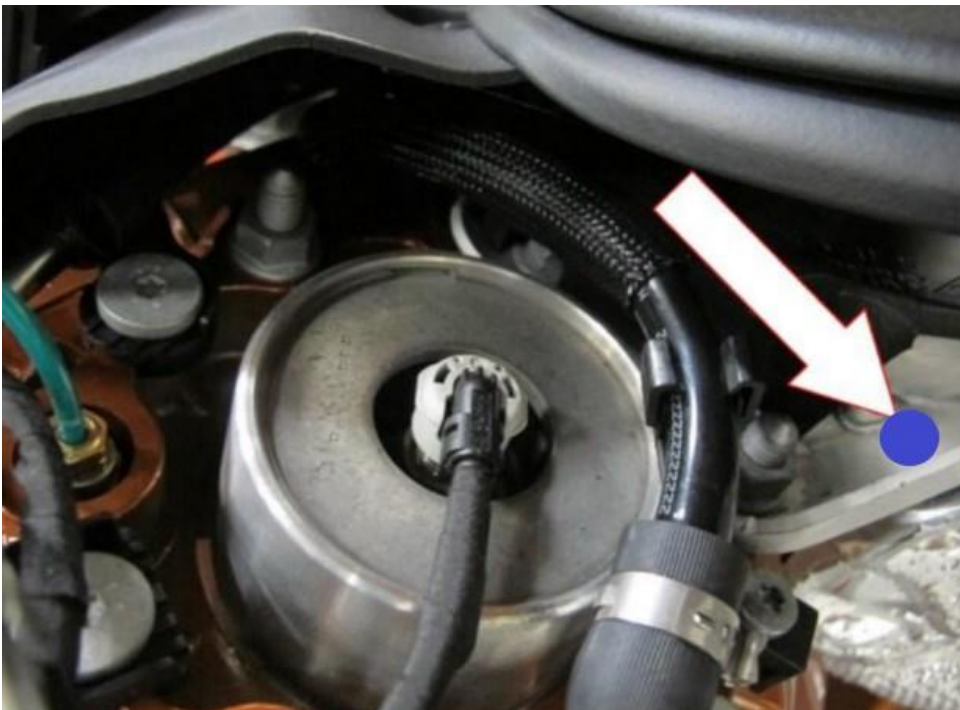
Figure 3

Blue paint completion mark on the engine partition brace

8) Referring to the Identification section - Apply a blue paint completion mark on the engine partition brace (Figure 3)
