June 19, 2024

Version 8

A/C Does Not Blow Cold Air and Condenser Leaks at Receiver Dryer Cap

Supersedes 18-080, dated July 16, 2019, to revise the information highlighted in **yellow**

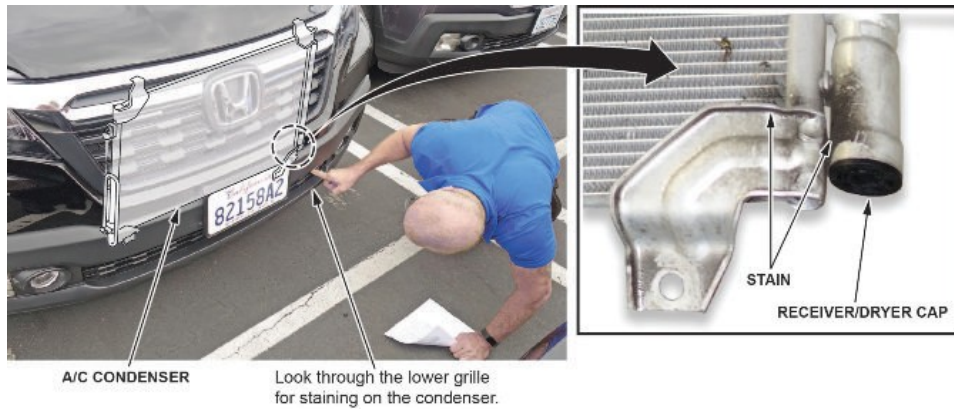
The A/C does not blow cold air, and the lower corner of the condenser around the receiver/dryer cap is stained.

There is poor O-ring compression against the receiver/dryer barrel wall.

Check if the A/C is blowing cold air and there is staining around the receiver dryer cap on the condenser.

- If the A/C is not blowing cold air and there is staining around the receiver dryer cap on the condenser, go to REPAIR PROCEDURE.
- If the A/C is not blowing cold air and there is no staining around the receiver dryer cap, continue with normal system troubleshooting.
