HYUNDAI
Technical Service Bulletin

GROUP BODY ELECTRICAL	NUMBER 24-BE-007H
DATE JUNE 2024	MODEL(S) SANTA FE (MX5A)

SUBJECT: COAXIAL CABLE SHIELD ADJUSTMENT FOR DISPLAY SCREEN FLICKERING/BLANK

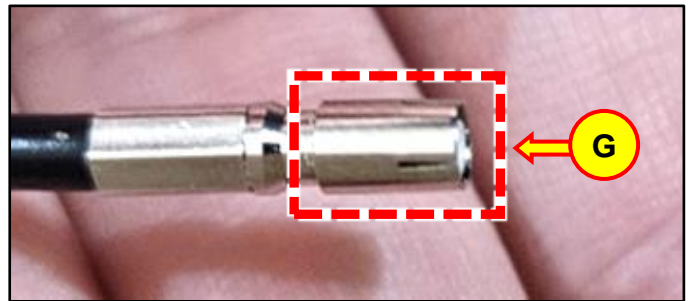
Notice that the coaxial cable shield is larger than the hole of the jig (H). Proceed to next step.

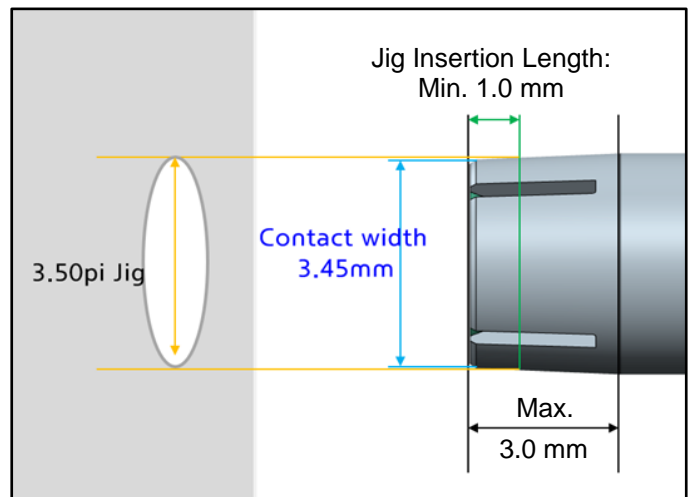
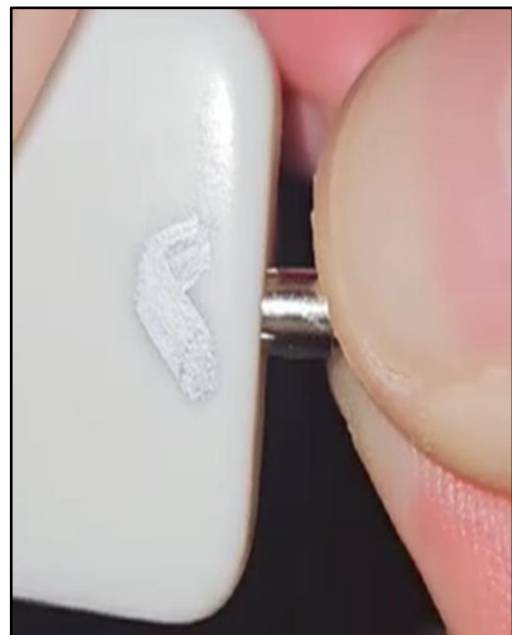
This will reduce the width of the shield to enable a better connection in the connector.

- Once inserted, rotate the jig around the shield 3 times.
