June 15, 2024

Version 1

Pop Noise From Rear of the Vehicle

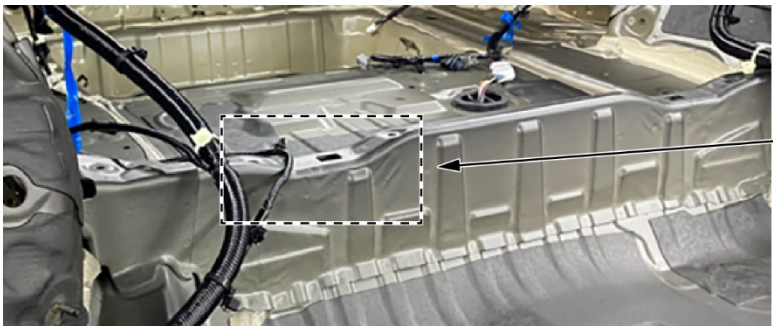
3. Check the orientation of the weld spots in the location shown.

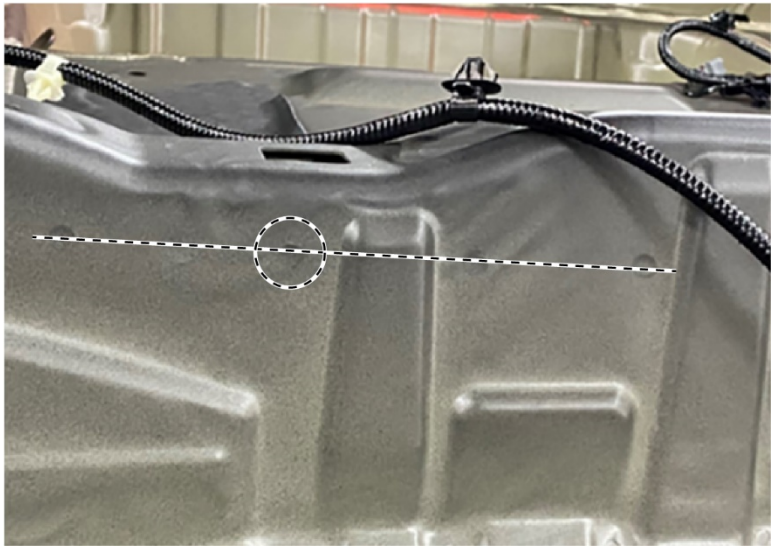
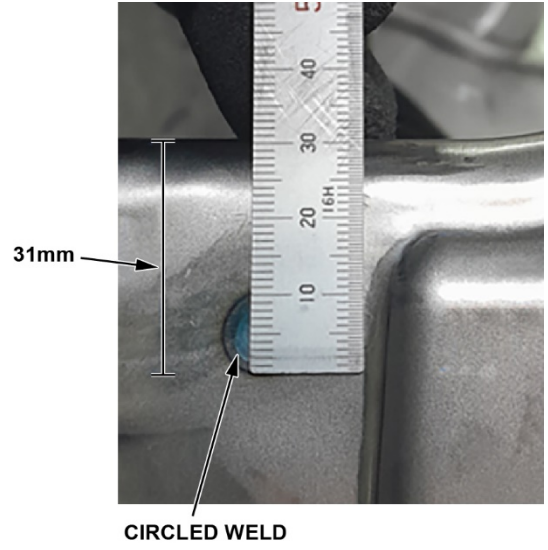
- If the welds are in a straight line and the weld that is circled measures **31 mm** from the top edge of the crossmember to the bottom of the weld, **this service bulletin does not apply**. Continue with normal troubleshooting.

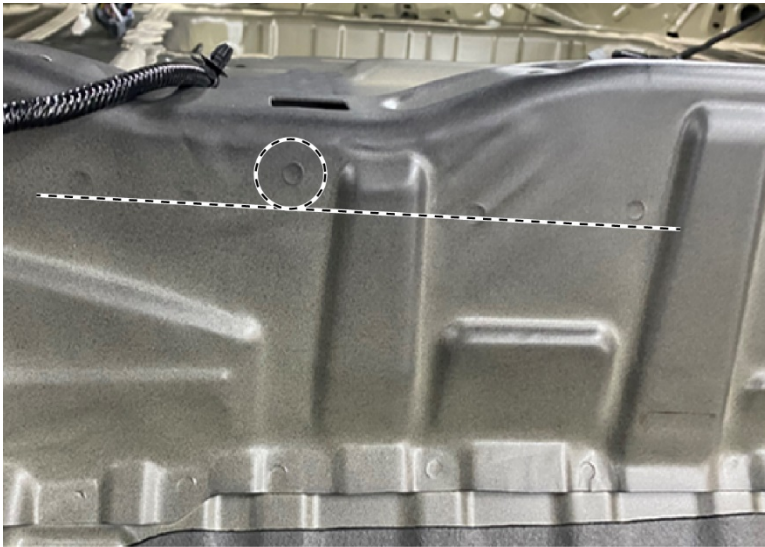
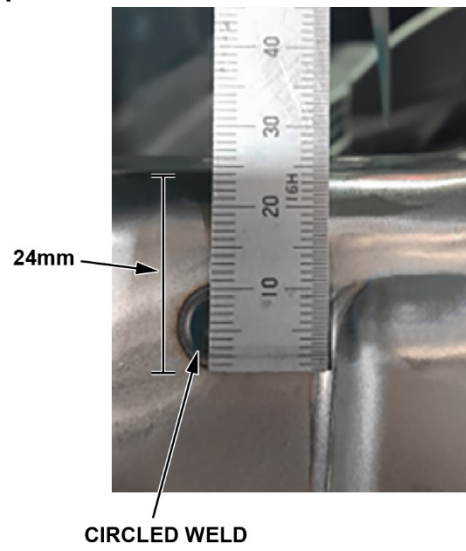
Pop noise in the left-rear third row seat area when driving down rough roads or turning.

Improper welds on the third row seat crossmember.

- If the welds are not in line and the weld that is circled is higher and measures **24 mm** from the top edge of the crossmember to the bottom of the weld, **continue to the next step**.

Drill spot welds and plug weld the crossmember.

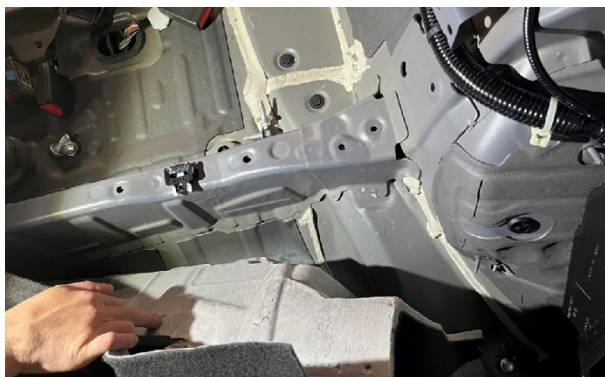
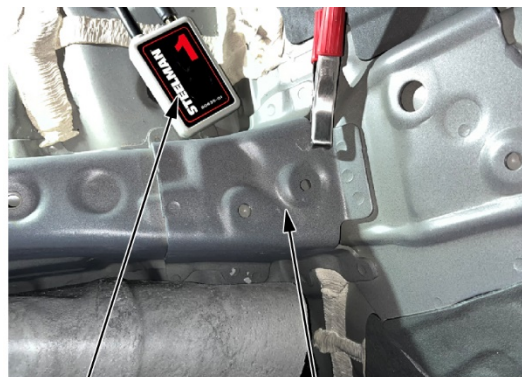
14. Pull back the carpet to expose the third row crossmember. Attach chassis ears on the left side gusset.

15. Test drive the vehicle to confirm if noise is coming from the third row crossmember gusset.

- If the pop noise is found to come from the crossmember gusset, proceed with the repair procedure to be performed at a body shop.
- If the noise is not a result of the crossmember gusset, continue with normal troubleshooting.
