## SERVICE BULLETIN

**APPLICABILITY:** 2017-22MY Impreza  
 2018-23MY Crosstrek  
 2019-23MY Forester  
 2022MY WRX

**NUMBER:** 07-221-23R

**SUBJECT:** Instrument Panel Wiring Harness & Rear Wiring Harness – Connector Corrosion

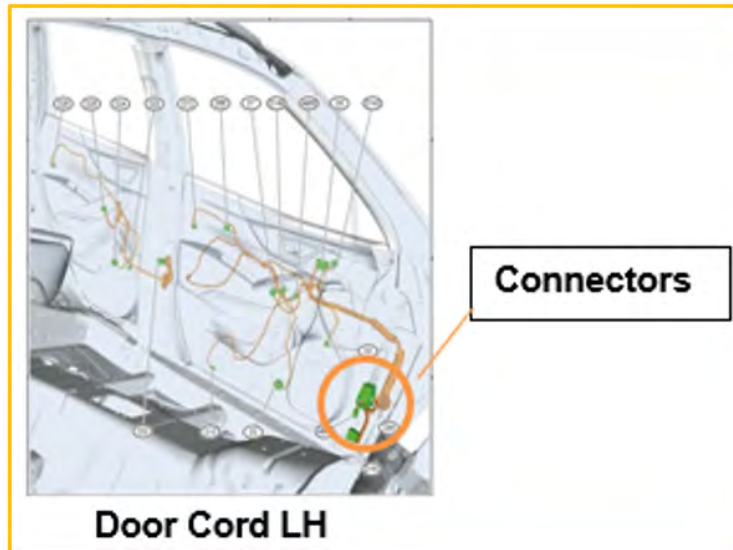
### Connector Details

Connector structure for **ONLY** the driver's side of Forester with Seat memory

Connector structure for others

1. Door Cord LH and Rear Wiring Harness Connector
2. Instrument Panel Wiring Harness and Rear Wiring Harness Connector
3. Instrument Panel Wiring Harness and Rear Wiring Harness Connector

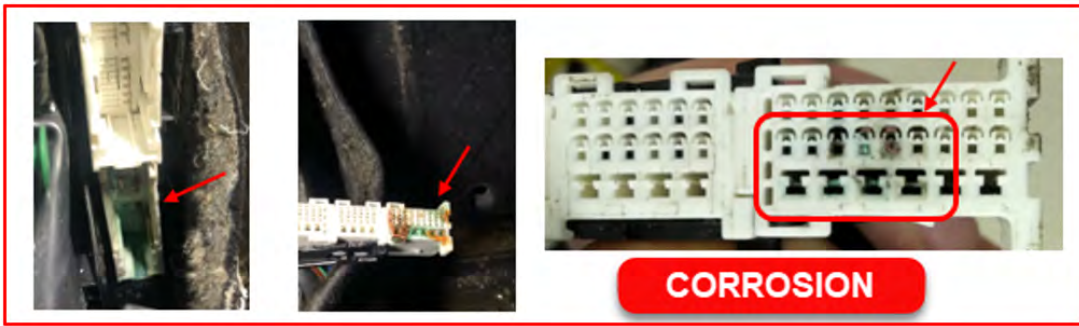
## EXAMPLES OF CORROSION:

This bulletin announces the repair procedures when corrosion is encountered within the instrument panel wiring harness and the rear wiring harness connectors. The corrosion is typically found in the footwell area as a result from moisture such as rain, snow, ice, and salt water being brought in from driver and/or passenger footwear. Corrosion in this area can cause multiple electrical malfunctions such as warning indicators and/or incorrect door position detection. If corrosion is found within this area(s), replace the affected wiring harness and perform the added procedure detailed below using the new repair kit. The purpose of the repair kit is to isolate the connections from any moisture damage.

There have been no changes to the wiring harnesses. The new repair kit and outlined procedures **MUST** be applied when replacing the affected harnesses for corrosion intrusion.

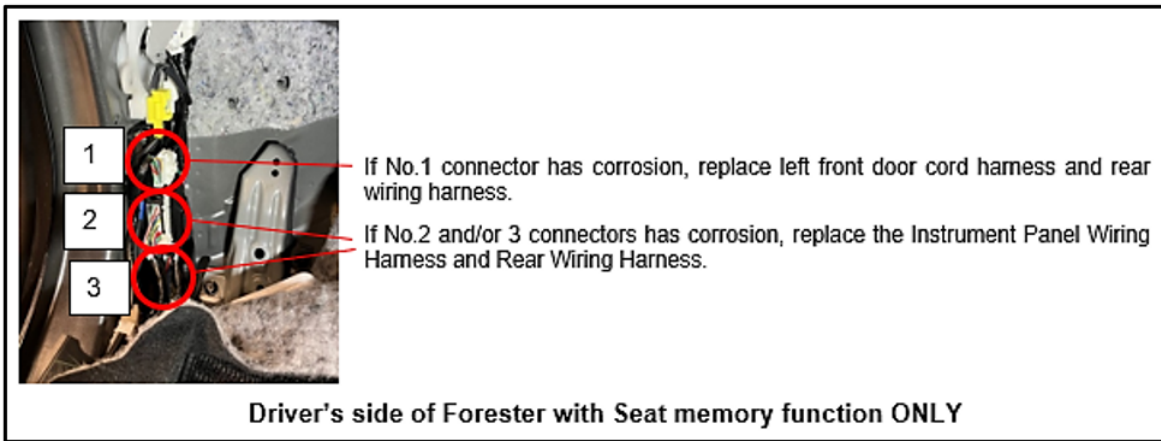
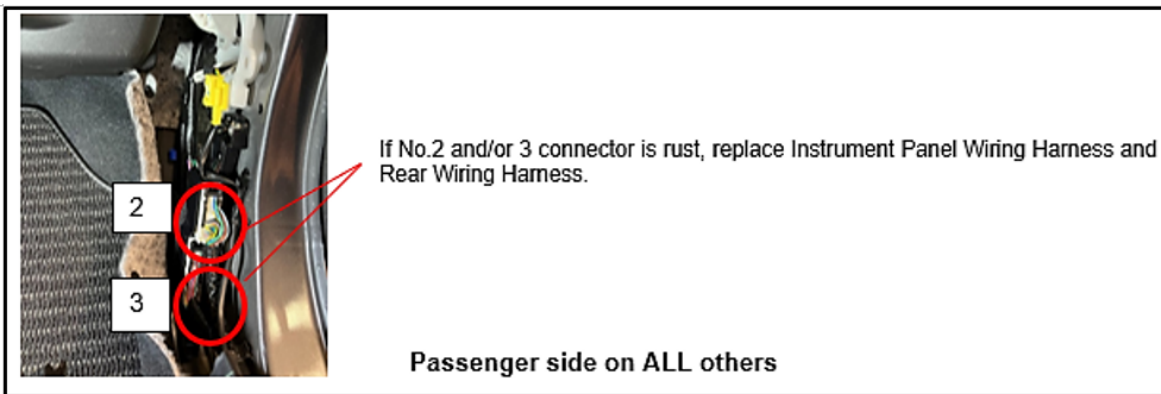
**STEP 1:** Remove the lower inner trim panel on the side of the vehicle with suspected corrosion. Expose the connections and confirm if corrosion is detected.

If corrosion is detected, the affected harnesses **MUST** be replaced. If no corrosion is found continue the vehicle diagnosis using the applicable Service Manual.

**STEP 2:** Replace the affected wiring harness. The service procedures for instrument panel, left front door cord, and the rear harnesses remain unchanged. Always refer to the applicable Service Manual and review the full requirements of the repair being performed. The Service Manual procedures contain information critical to performing an effective repair the first time, every time. This includes but is not limited to important SAFETY precautions, proper inspection criteria, necessary special tools, required processes and related one-time-use parts needed for a complete and lasting repair.
