Technical Service Bulletin (TSB)
Diesel Exhaust Fluid (DEF) Fluid Freezing

REFERENCE:	TSB: 14-005-24 GROUP: 18 - Vehicle Performance	Date:	June 28, 2024	REVISION:	14-003-23
VEHICLES AFFECTED:	<p>2019 - 2022 (DJ) RAM 2500 Pickup 2019 - 2022 (D2) RAM 3500 Pickup 2019 - 2022 (DD) RAM 3500 Cab Chassis 2019 - 2022 (DP) RAM 4500/5500 Cab Chassis This bulletin applies to vehicles equipped with the 6.7L I6 Cummins Turbo Diesel engine (Sales Codes ETL and ETN) or a 6.7L I6 Cummins HO Turbo Diesel engine (Sales Code ETM).</p>	MARKET APPLICABILITY:			
		<input checked="" type="checkbox"/> NA		<input type="checkbox"/> MEA	
		<input type="checkbox"/> SA		<input type="checkbox"/> IAP	
		<input type="checkbox"/> EE		<input type="checkbox"/> CH	
CUSTOMER SYMPTOM:	<p>**Customers must experience a Malfunction Indicator Lamp (MIL) illumination and the vehicle must exhibit/set the following Diagnostic Trouble Code (DTC):**</p> <ul style="list-style-type: none"> ● P203E-00 - Reductant Level Sensor 1 Circuit Intermittent-Erratic. <p>Customers may also experience one or more of the following:</p> <ul style="list-style-type: none"> ● Repeated freeze/thaw cycles of the urea tank to cause solid DEF crystal

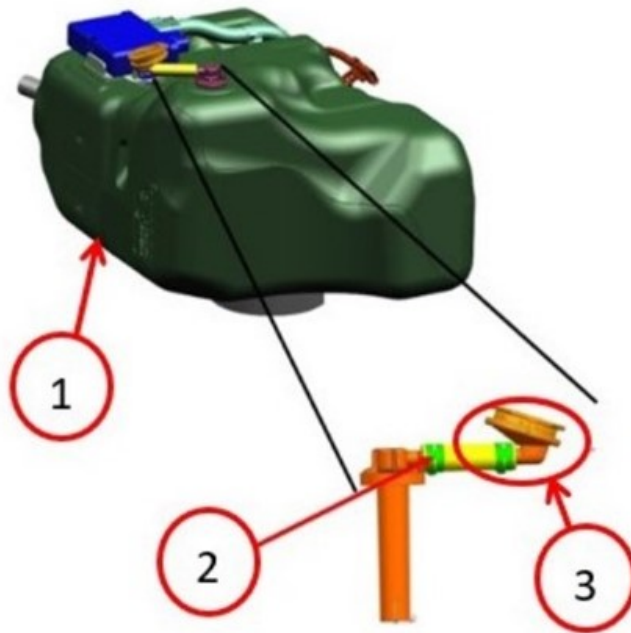
Fig. 1
DEF Tank Assembly

CAUSE:	DEF fluid freezing

1. ****Loosen the hose clamp on the Grade Vent Valve (GVV) hose and replace the GVV from the DEF tank Fig. 1.**
