<b>REFERENCE:</b>	<b>TSB:</b> 08-153-24 <b>GROUP:</b> 08 - Electrical	<b>Date:</b>	June 29, 2024	<b>REVISION:</b>	08-112-23
<b>VEHICLES AFFECTED:</b>	<b>**2017 - 2025** (MP) Jeep Compass</b> <b>**2021 - 2024** (WL) Jeep Grand Cherokee / **Grand Cherokee L**</b> <b>2022 - 2023 (WS) Grand Wagoneer/Wagoneer</b> <b>2019 - 2023 (KL) Jeep Cherokee</b>			<b>MARKET APPLICABILITY:</b>	
				<input checked="" type="checkbox"/> NA	<input checked="" type="checkbox"/> MEA
				<input checked="" type="checkbox"/> SA	<input checked="" type="checkbox"/> IAP
				<input checked="" type="checkbox"/> EE	<input checked="" type="checkbox"/> CH
<b>CUSTOMER SYMPTOM:</b>	<p>On occasion, vehicle exterior taillamp assemblies are fogged with a light layer of condensation on the inside of the lenses <b>Fig. 1</b>. This may be reported after the lamps have been turned on and brought up to operating temperature, turned off and then rapidly cooled by cold water (such as rain, or the water from a vehicle wash).</p> <p>Lens fogging can also occur under certain atmospheric conditions after a vehicle has been parked outside overnight (i.e. a warm humid day followed by clear cool night). This will usually clear as atmos

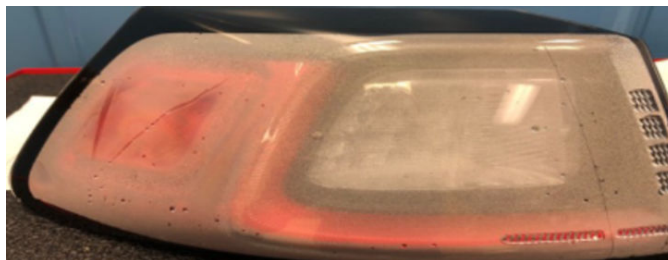
**Fig. 1**

<b>CAUSE:</b>	Condensation/moisture build up in the taillamp assembly.

Taillamp Assembly With Condensation

- b. If the condensation/fogging has **not** begun to clear after 60 minutes with the taillamps operating, or the lamp has large amounts of water droplets visible on most internal surfaces, this indicates a problem with the taillamp sealing that has allowed water to enter the taillamp. In this instance, the customer is also likely to report that moisture in the taillamp is always present and never disappears [Fig. 1](#).

A taillamp that exhibits internal moisture permanently should be replaced. Refer to the detailed service procedures available in DealerCONNECT/Service Library under: Service Info> 08 -Electrical / 8L - Lamps and Lighting / Lamps/Lighting - Exterior / Lamp, Tail / Removal.

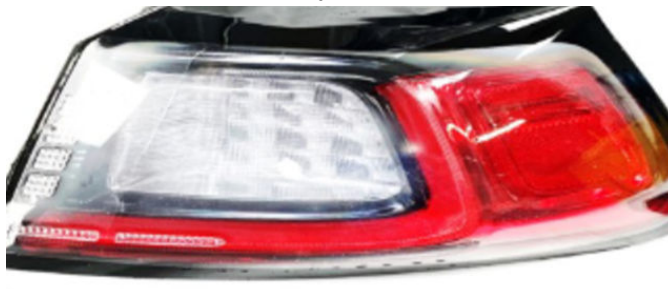
**Fig. 2**

Clear Taillamp Assembly

2. The taillamp assembly should be checked every 10 minutes.
  - a. If the condensation/fogging has begun to clear from the taillamp assembly within 60 minutes with the taillamps operating, this indicates the taillamp sealing has not been breached and **the taillamp assembly does not need to be replaced** [Fig. 2](#).
