REFERENCE:	TSB: 08-155-24 GROUP: 08 - Electrical	Date:	June 29, 2024	REVISION:	—
VEHICLES AFFECTED:	2023 (RU) Chrysler Pacifica This bulletin applies to vehicles equipped with Seatback Video Screens (Sales Code RHH).			MARKET APPLICABILITY: <input checked="" type="checkbox"/> NA <input type="checkbox"/> MEA <input type="checkbox"/> SA <input type="checkbox"/> IAP <input type="checkbox"/> EE <input type="checkbox"/> CH	
CUSTOMER SYMPTOM:	Customers may comment on the following: <ul style="list-style-type: none"> • Rear seat entertainment screens are blank. • VRM not turning on during ignition cycle. 				
CAUSE:	VRM software update

This bulletin involves updating the VRM with the latest available software.

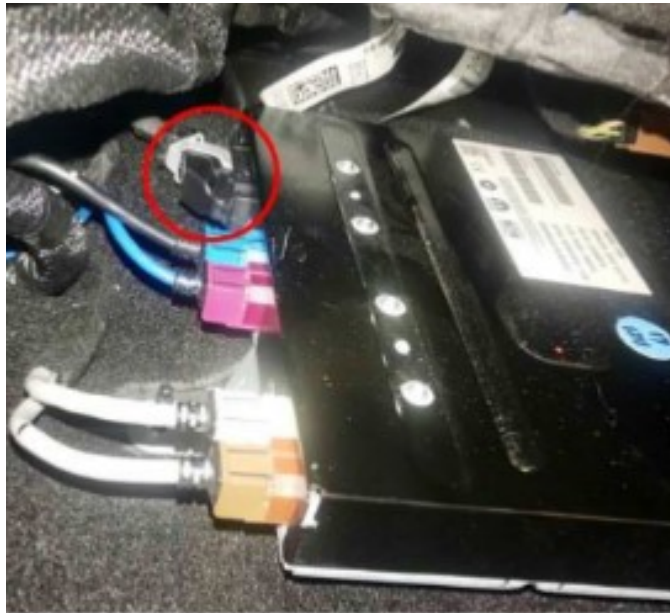
Fig. 1
VRM (C1) Connector

NOTE: If VRM is not responsive on CAN bus or both rear screens are not turning on, turn off ignition, disconnect the Black (C1) VRM and reconnect. Verify screens turn on when ignition is turned back on.

1. Are the rear seat entertainment screens functional?
 - YES>>>Proceed to [Step 5](#).
 - NO>>> Proceed to [Step 2](#).
2. With the vehicle ignition OFF, move the front passenger seat all the way rearward, disconnect and reconnect the Black (C1) VRM harness connector from VRM found under the front passenger seat [Fig. 1](#).
