Technical Service Bulletin (TSB)

Flash: Video Routing Module (VRM) System Updates

REFERENCE:	TSB: 08-156-24 GROUP: 08 - Electrical	Date:	June 29, 2024	REVISION:	08-154-22 REV. A
VEHICLES AFFECTED:	2022 (RU) Chrysler Pacifica This bulletin applies to vehicles equipped with Seatback Video Screens (Sales Code RHH).			MARKET APPLICABILITY: <input checked="" type="checkbox"/> NA <input type="checkbox"/> MEA <input type="checkbox"/> SA <input type="checkbox"/> IAP <input type="checkbox"/> EE <input type="checkbox"/> CH	
CUSTOMER SYMPTOM:	Customers may comment on the following: <ul style="list-style-type: none"> Rear seat entertainment screens are blank. VRM not turning on during ignition cycle. 				
CAUSE:	VRM software update

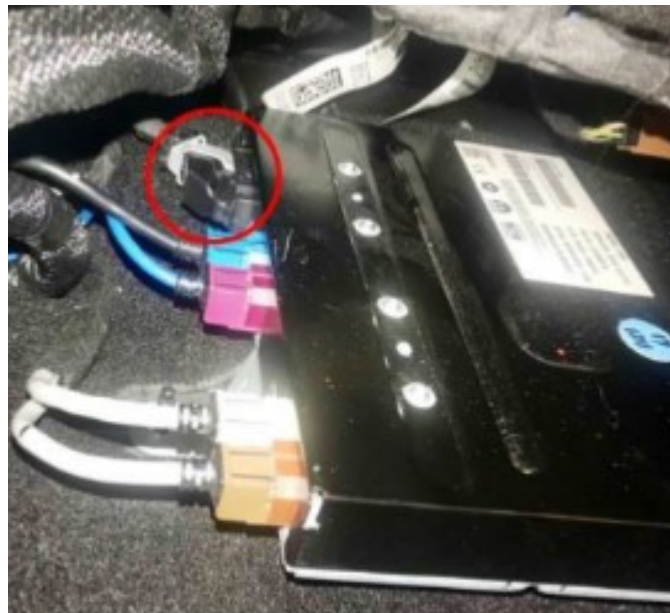
Fig. 1
VRM (C1) Connector

NOTE: If VRM is not responsive on CAN bus or both rear screens are not turning on, turn off ignition, disconnect the Black (C1) VRM and reconnect. Verify screens turn on when ignition is turned back on.

- Are the Seatback Video Screens functional?
 - YES>>>Proceed to [Step 5](#).
 - NO>>> Proceed to [Step 2](#).
- With the vehicle ignition OFF, move the front passenger seat all the way rearward, disconnect and reconnect the Black (C1) VRM harness connector from VRM found under the front passenger seat [Fig. 1](#).
