**Volvo Chassis - Models VNL, VNX Only  
Equipped With A USD16 Volvo Engine -  
AHI Harness Failure Related Fault  
Codes P249F00, P20DD13, P113413**

Published 7 June 2024

Valid for Volvo VNL and VNX, model years 2011 to 2017

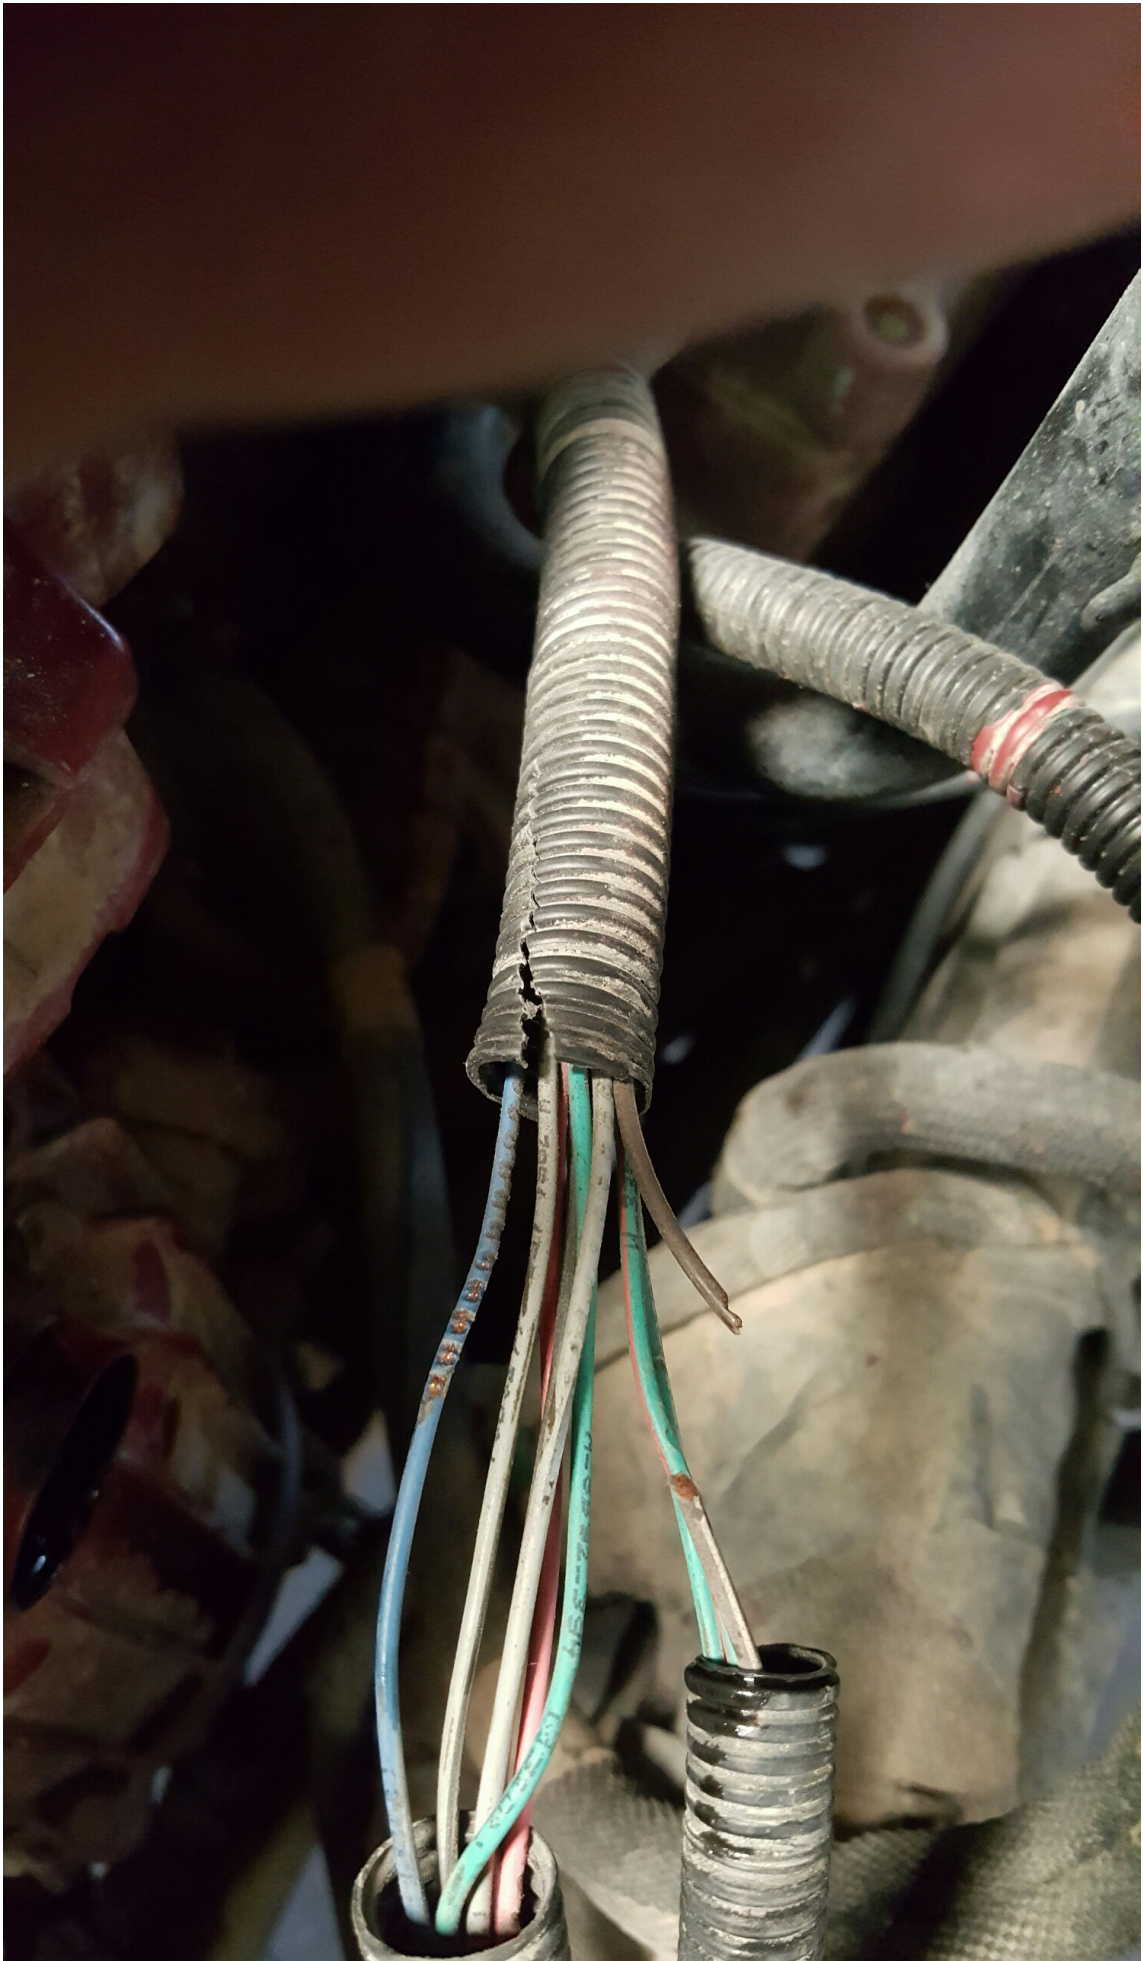
Once the AHI harness has been inspected and found to have failed internally, example as seen in the picture below, it will need to be replaced.
