STAR ONLINE PUBLICATION

Case Number: S1408000384 Rev. E

Release Date: June 2024

Symptom/Vehicle Issue: Start Stop Charging Warning Lamp Illuminated On, Intelligent Battery Sensor (IBS) State of Charge (SOC) Inaccurate, Battery Charging Message, Presence of IBS related Diagnostic Trouble Codes (DTCs), or Battery Warning Lamp On

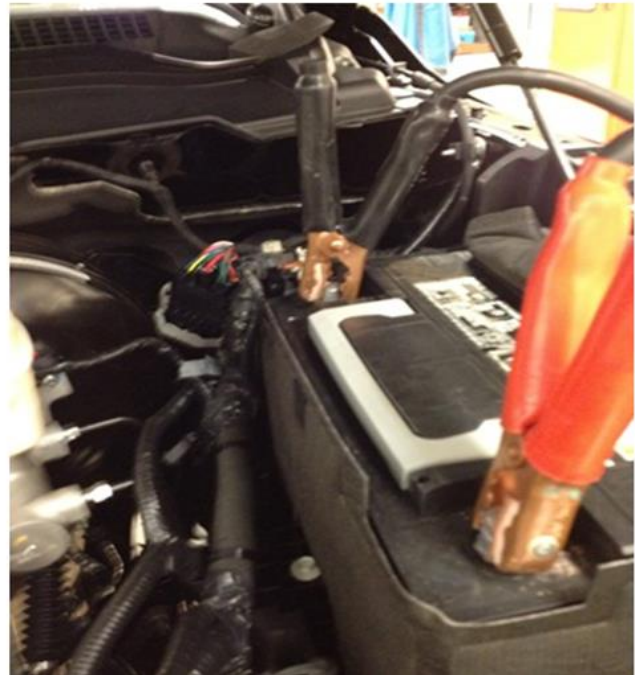
Improper IBS Charging

Do not put Negative clamp on IBS Pole clamp

Do not remove IBS for charging

In-Vehicle systems is not an issue. Please note to charge through the IBS or tie negative clamp to Body/engine ground. Customers, Dealers, Mechanics, and Engineers usually want to place the negative clamp on the pole of the battery. This creates Blind charging. **“DO NOT BLIND CHARGE”** See below proper connections for charging.
