Technical product information

Topic	Front seat adjustment switch broken / damaged - Warranty exclusion for damaged / broken parts
Market area	Australia E04 Bentley rest Asia and Australia (6E04),China 796 VW Import Comp. Ltd (Vico), Beijing (6796),Germany E02 Bentley rest Europe (6E02),Japan E03 Bentley Japan (6E03),Korea, (South) E08 Bentley South Korea (6E08),United Arab Emirates E06 Bentley Middle East and Africa (6E06),United Kingdom E01 Bentley UK (6E01),United States E05 Bentley USA and rest America (6E05)
Brand	Bentley
Transaction No.	2072330/2
Level	EH
Status	Approval
Release date

New Continental GT / GTC and New Flying Spur

Front seat adjustment switch is broken / damaged

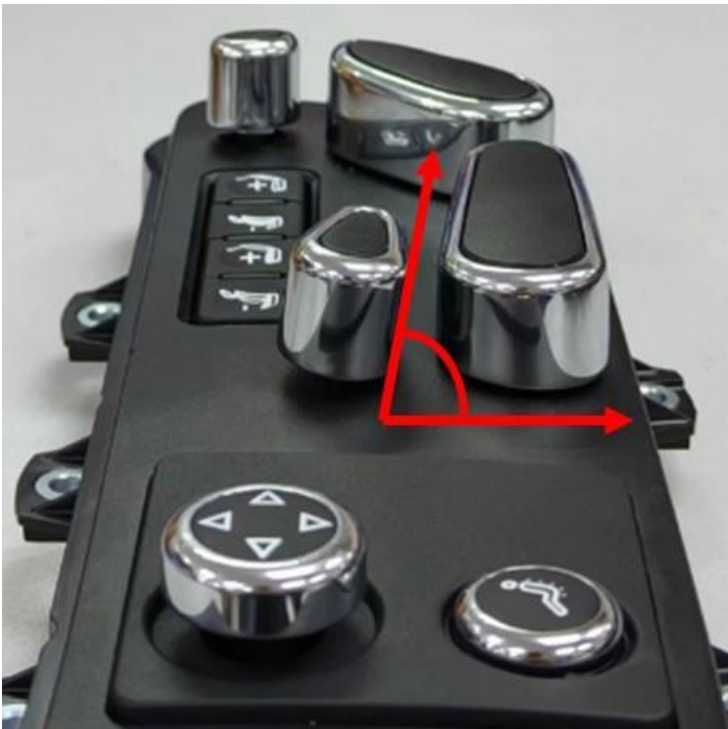
Referring to Figure 1 - The seat cushion switch is out of position

Testing performed by Bentley Motors confirms that circa 250N of force is required to break the switches described, therefore any claims for broken seat switches under warranty will be rejected

Refer to the Technical background and Warranty instruction sections of this TPI

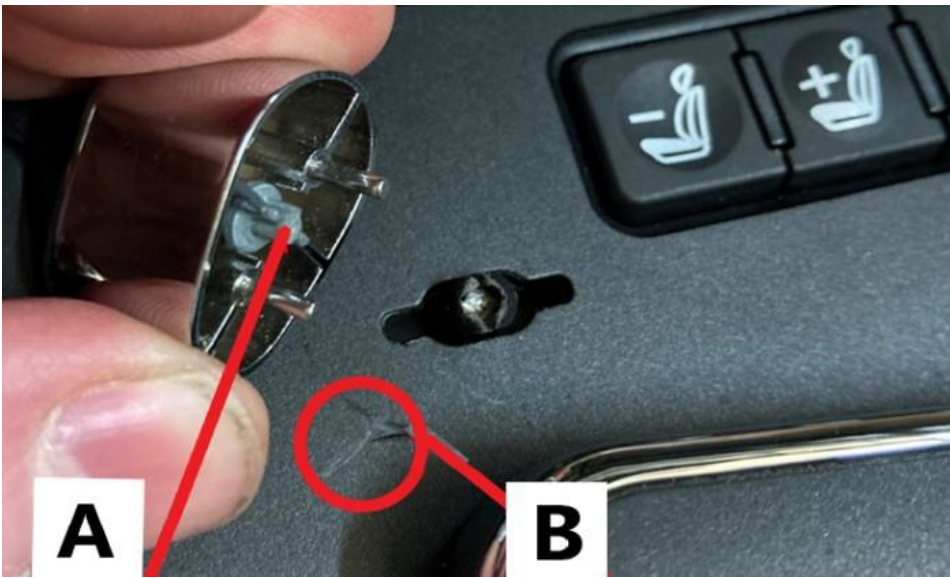
Referring to Figure 2 - The leg support cushion switch is broken (Point A)

Damage is also evident on the switch pack outer cover (Point B) due to excess force being applied to the switch
