**Cayenne E-Hybrid – Thermal Management Fault P26B100 Causes Check Engine Light**

**Vehicles Affected**

**Condition**

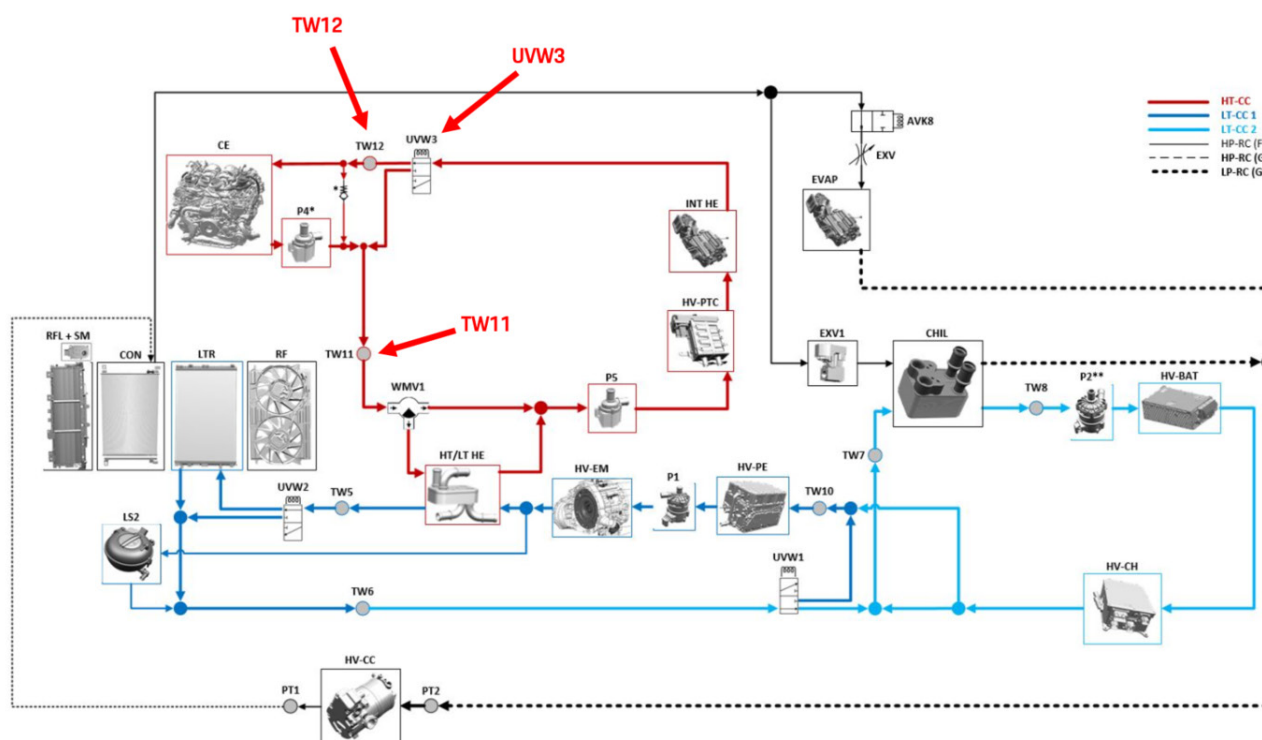
**Figure 1 - Cayenne E-Hybrid Cooling Circuits**

The aforementioned fault code may be caused by a misdiagnosis of the directional control valve for the high temperature circuit for interior heating (valve UVW3).

Under certain operating conditions, a lack of temperature difference between the engine coolant circuit and the interior heating circuit may result in the TME diagnosing valve UVW3 as “stuck closed”, despite no mechanical fault in the valve.

Valve UVW3 controls the direction of coolant flow based on engine temperature. The valve defaults to closed, such that the high-temp circuit excludes the engine coolant circuit. During this “small-circuit” operation, the HV PTC controls the temperature of the high-temp circuit to meet the heating and air conditioning demands of the customer. Once the engine reaches 40° C, the valve opens (“large-circuit” operation) and the high-temp circuit uses the engine heat instead of the HV PTC.

The status of UVW3 is diagnosed by the absolute value of the temperature difference between TW11 and TW12. The TME expects this difference to be **larger than 7° C while the valve is closed, but smaller than 7° C while the valve is open**. Certain operating conditions may cause the temperature difference to fall below 7° C while the valve is closed. If this condition exists while the TME is performing diagnostics, the valve will be diagnosed as open, although it is closed due to the engine temperature being less than 40° C.

1. Please create a VAL to document the occurrence of the fault.
2. If applicable, please complete Workshop Campaign WPRO. Please complete this Campaign per the instructions in TI 177/23, before performing any other diagnosis work for the subject fault code.  
**NOTE:** Please reference the below table for the appropriate TME software and coding information after completing Campaign WPRO. (Data Record Version can be found in the Extended Identifications tab for the TME.)

3. If the fault persists after performing WPRO, please continue with other means of diagnosis.
