APB5 - Replacing the Cell Block Module on High-Voltage Battery (Recall Campaign)

Vehicle Type: **Taycan (Y1A / Y1B / Y1C)**

Model Year: **As of 2020 up to 2024**

Concerns: **Cell block module**

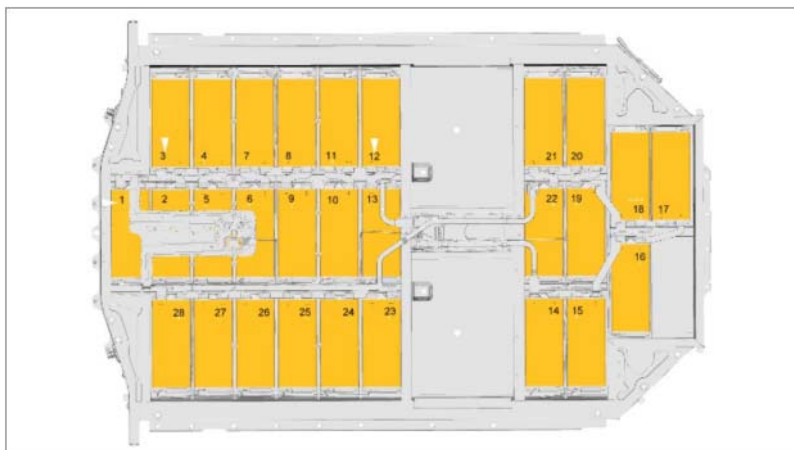
28-module high-voltage battery version

Counting the modules of a 28-module high-voltage battery is different from counting the modules of a 33-module high-voltage battery.

3 Remove the affected cell block module. For instructions, see *⇒ Workshop Manual '270855 Replacing cell block module'*
