SIB 64 05 21

2024-06-04

RATTLING NOISE PERCEPTIBLE IN VEHICLE INTERIOR WITH AC ACTIVATED

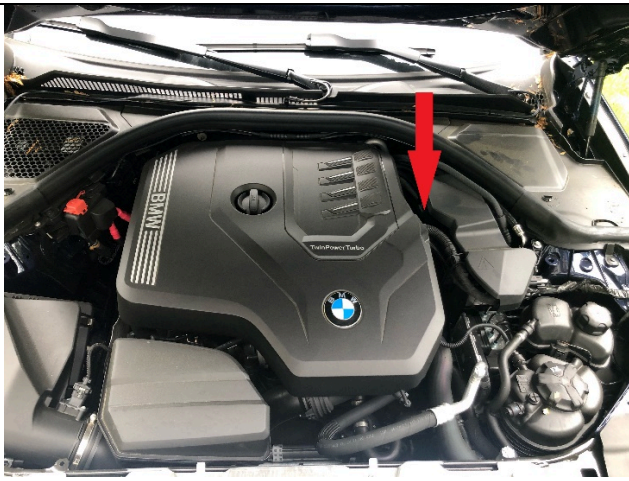
The refrigerant line double pipe and a clamp on the return line of the internal heat exchanger are in line with each other (in the direction of travel, on the left (driver) side of the engine compartment below/behind the DME) and are making contact.

The hoses are contacting here (arrow).
