9YA/9YB – Roof Console Lights Malfunction

Vehicles Affected

Models	Model Year	Model Type	VIN Range	Vehicle-Specific Equipment
Cayenne	2024	9YA, 9YB	N/A	N/A

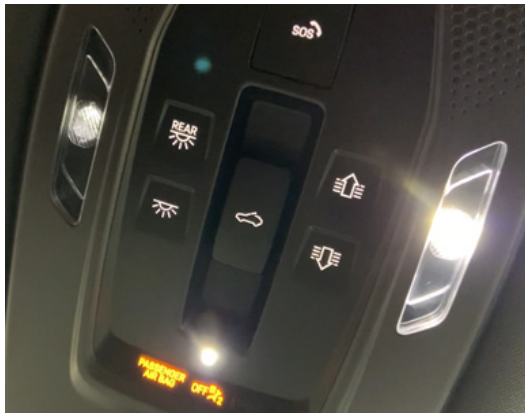
Figure 1- Overhead console dimming

Customer complains of roof console lights turn on and off without input.

Internal contact of the overhead console between the printed circuit board and housing, causing the lights to dim or turn on and off without input, due to material composition. There are no fault codes relevant to the concern.

1. Verify the concern is as isolated to the conditions described above.
2. Create a Pre-VAL.
3. In the VAL, check the ECU information in the "interior lighting in front roof console" unit. (refer to Figure 2)
4. If the Hardware version is 51, refer to Figure 3 to find the appropriate part number and replace the roof console with the appropriate revised part number.
5. If replaced, Verify operation of the replacement console.
6. Create a Post-VAL.
