THIS IS A TECH TIP, NOT A TECHNICAL BULLETIN.

15-24-01TT - Valve Stem Seal Installation

Release date: 6/13/2024

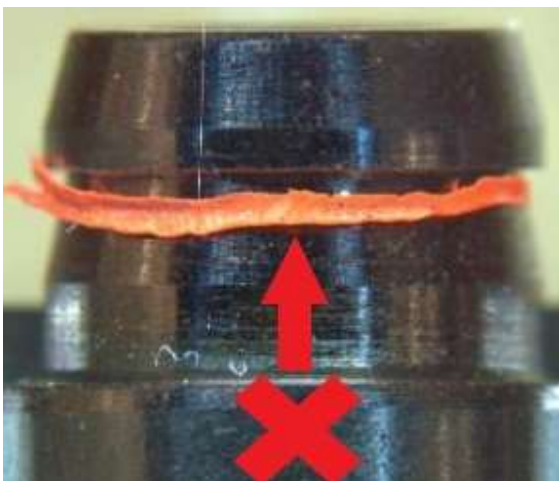
Figure 1.

Remnants of the valve stem seal on the valve guide can interfere with the installation of new valve stem seals and cause them to not seat properly. See Figure 1 below for an example.

When servicing or replacing the valve stem seals, check the valve guide for any signs of valve stem seal material under the valve guide groove, and if necessary, remove the remaining material before installing new valve stem seals. Care should be taken not to damage the valve guide, so use of a fine pick tool or small razor blade should be done so carefully.
