91-23-02 - Various Infotainment Concerns

Release date: 6/3/2024

Applicable Vehicles					
Model(s)	Year	Eng. Code	Trans. Code	VIN Range From	VIN Range To
Golf R, GTI	2022 - 2024	All	All	All	All

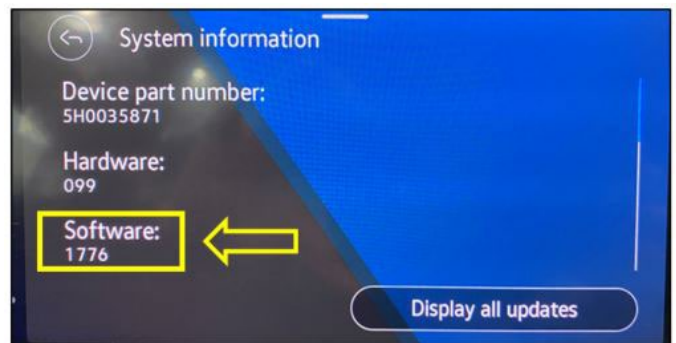
Once in Settings select "System Information" to check the current software level.

If the current software level is lower than **1805**, proceed with this Technical Bulletin.

If the current software level is equal to or greater than **1805**, this work procedure does not apply.
