94-23-01 - Headlamp: Rubber lip-seal (between headlight and fender) loose

Release date: 6/13/2024

Applicable Vehicles					
Model(s)	Year	Eng. Code	Trans. Code	VIN Range From	VIN Range To
Golf R, GTI	2022 - 2024	All	All	All	All

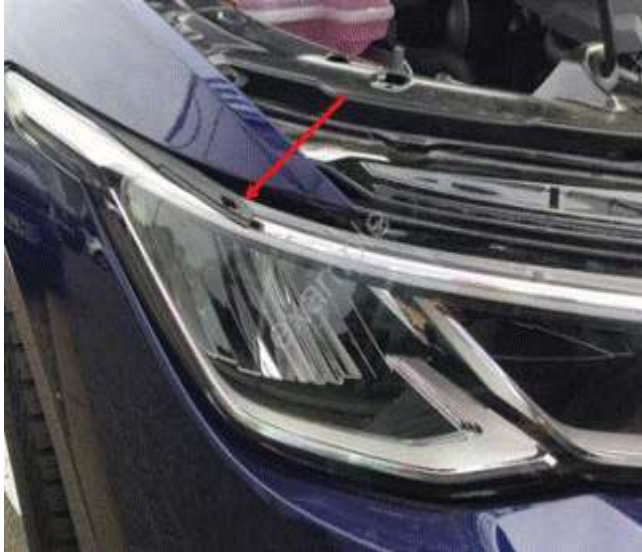
Figure 1.

Incorrect assembly of the rubber lip/seal in the assembly process. This can result in damage to the locking lug. As a result of the damage to the locking lug, the rubber lip/seal comes loose or protrudes.

The rubber lip/seal (see Figure 1, red arrow) between the headlamp and the fender (left/right) is loose/detaching/is off.

Glue the rubber lip/seal
