Title: A/C Condensers for LT and RH Part Number Update

Applies To: LT and RH built before Nov 20th, 2017

This document will show the user the difference between original production and new A/C Condensers for LT and RH vehicles.

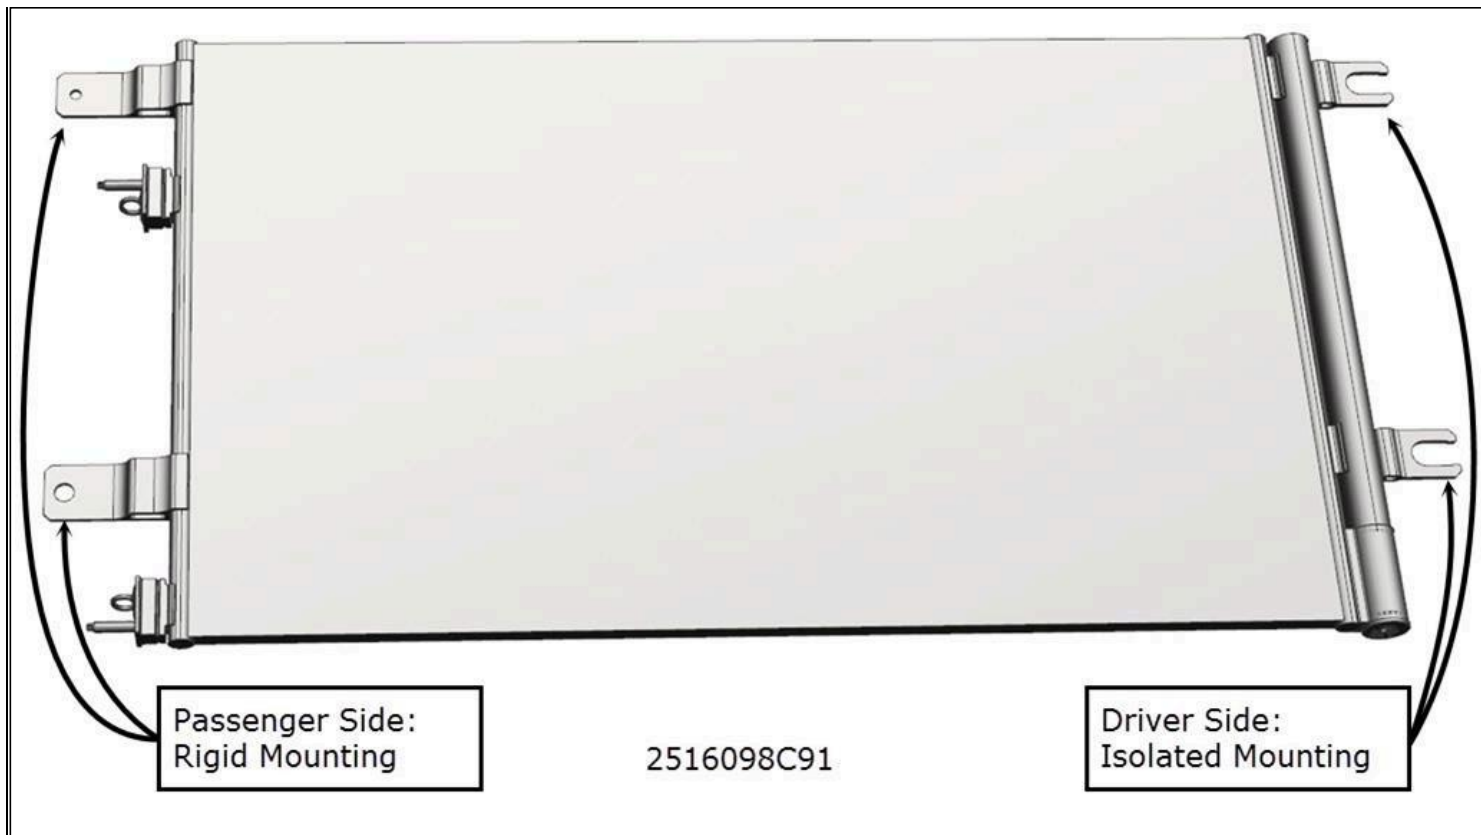
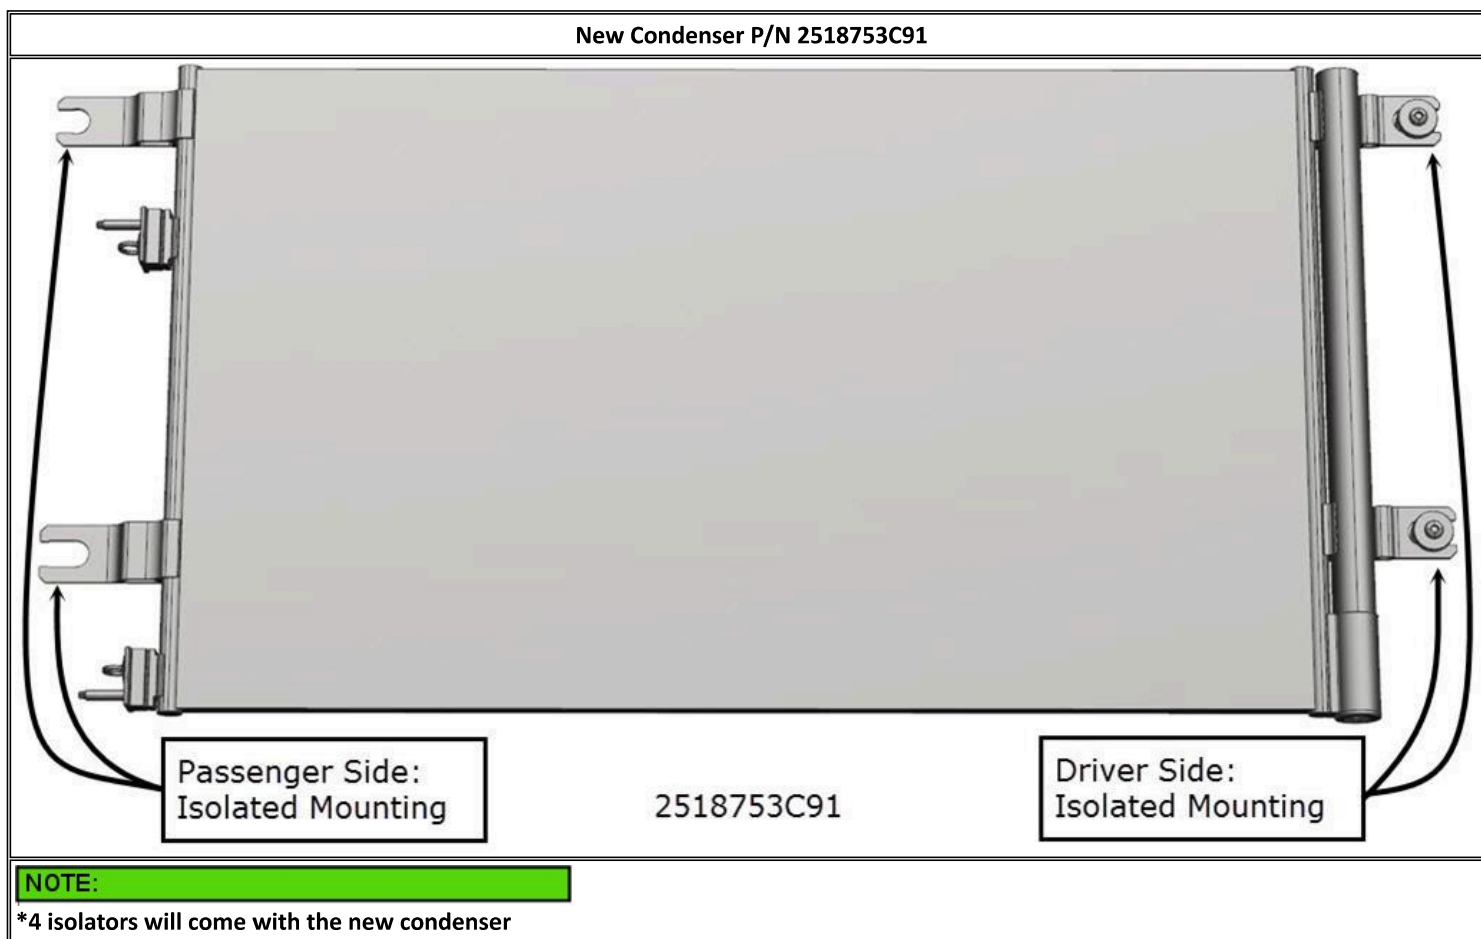
| Old Condenser P/N 2516098C91 |

Condenser P/N 2516098C91 has been replaced with P/N 2518753C91, see images below:

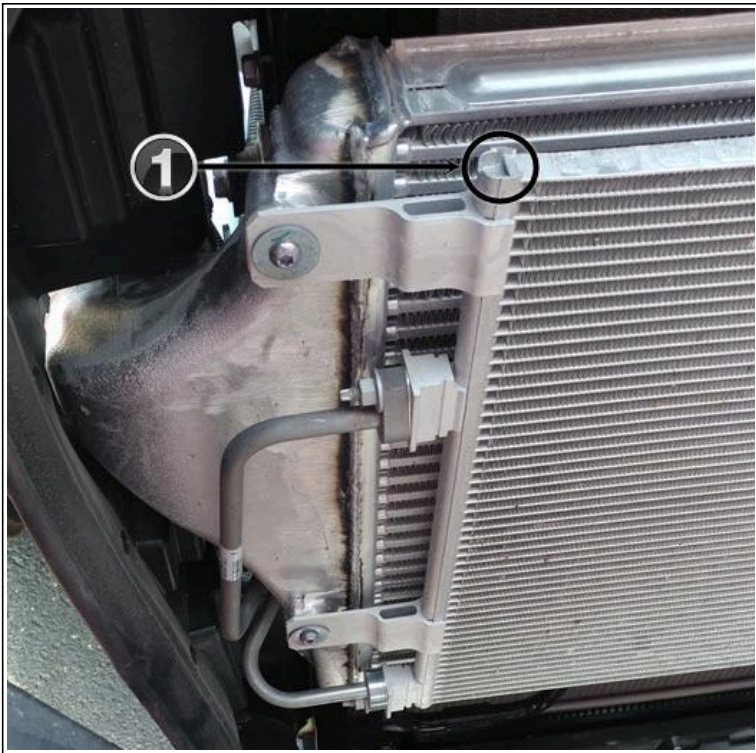
Identify Microchannels on Condenser

The New Condenser can also be identified by the number of microchannels in the tubes

1. Microchannels can be seen on the top or bottom tube of the condenser
  - o The top and bottom tube are not functional

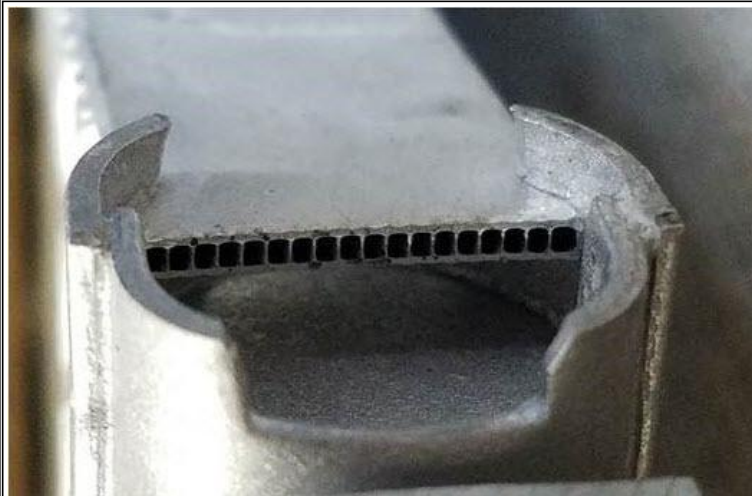
#### Original Condenser - 18 Microchannels

- A small number of production vehicles had 4 isolators with the 18 Microchannel design (Built between 10/17/2017 and 11/08/2017)
- 4 Isolators with 18 Microchannels was never available as a service part
