## Field campaign

<b>Topic</b>	Emergency call module and communication unit (0075) - Software update - Dongle removal (SC24/13)
<b>Market area</b>	United States E05 Bentley USA and rest America (6E05)
<b>Brand</b>	Bentley
<b>Transaction No.</b>	2073967/1
<b>Campaign number</b>	ED06
<b>Note</b>	
<b>Type</b>	
<b>US code</b>

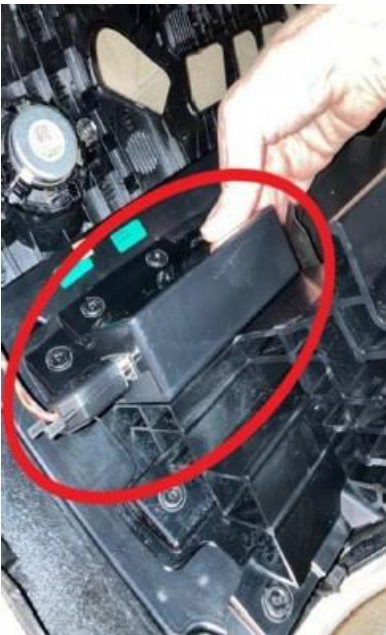
Figure 1

The previously installed dongle (Figure 1) requires removal (Refer to the Work section for all instructions)

2) With care remove the dongle assembly (Figure 1) from the dashboard panel as follows:

- Disconnect the dongle plug from the diagnostic socket
- Remove the dongle assembly from the dashboard panel
- Take a clear photograph of the removed dongle ensuring the photograph clearly shows the dongle reference number

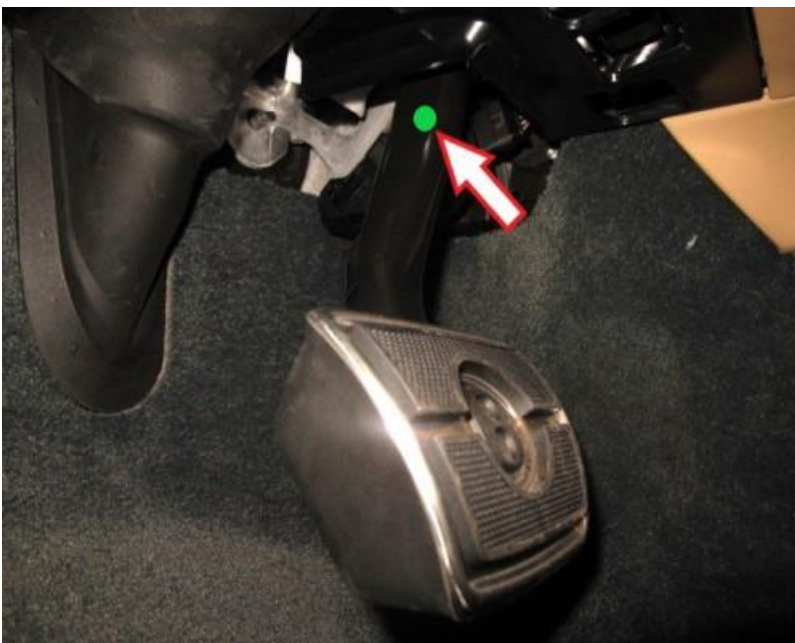
Green paint completion mark at the location shown in Figure 6 confirms completion

11) Apply a green paint completion mark on the brake pedal arm as shown in Figure 6
