Technical Service Bulletin

57 Power closing door latch is intermittently inoperative, door adjustment is required

57 24 45 2058159/6 June 17, 2024. Supersedes Technical Service Bulletin Group 57 number 23-10 dated June 13, 2023 for reasons listed below.

Model(s)	Year	VIN Range	Vehicle-Specific Equipment
Q7	2017 - 2025	All	Power door closing latch
SQ7	2020 - 2025

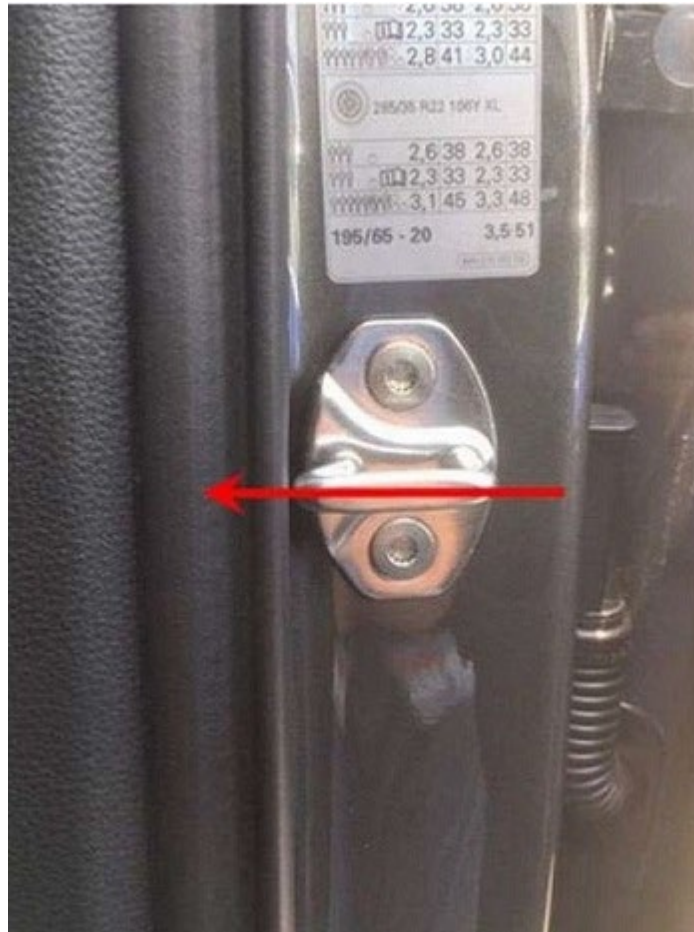
Figure 1. Adjust door striker inward by at least 0.5 mm.

1. Check the door striker to latch alignment and perform any adjustments necessary to center the striker to the latch.
2. At the same time, adjust the door striker inward as far as possible (at least 0.5 mm) (Figure 1). The front door can be flush or slightly under flush to the rear door without causing a wind noise concern (Figure 2).

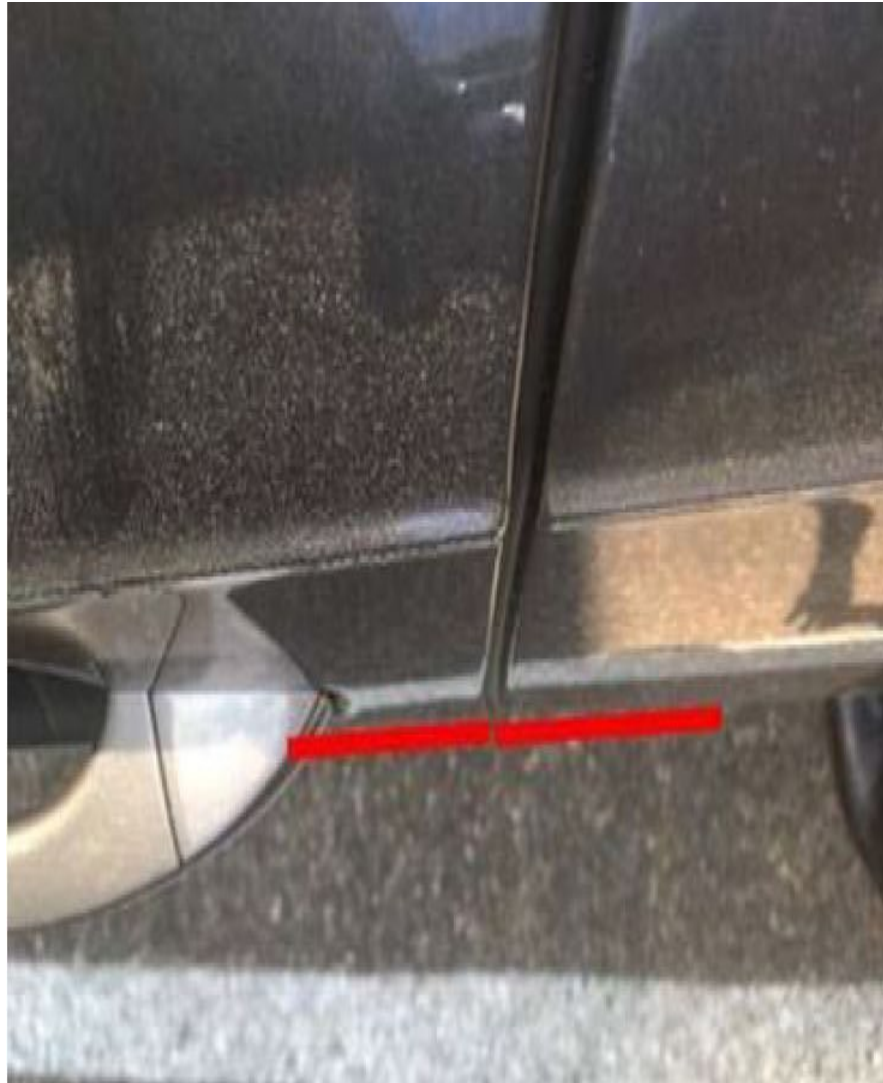
Figure 2. The front door can be flush or slightly under flush to the rear door.

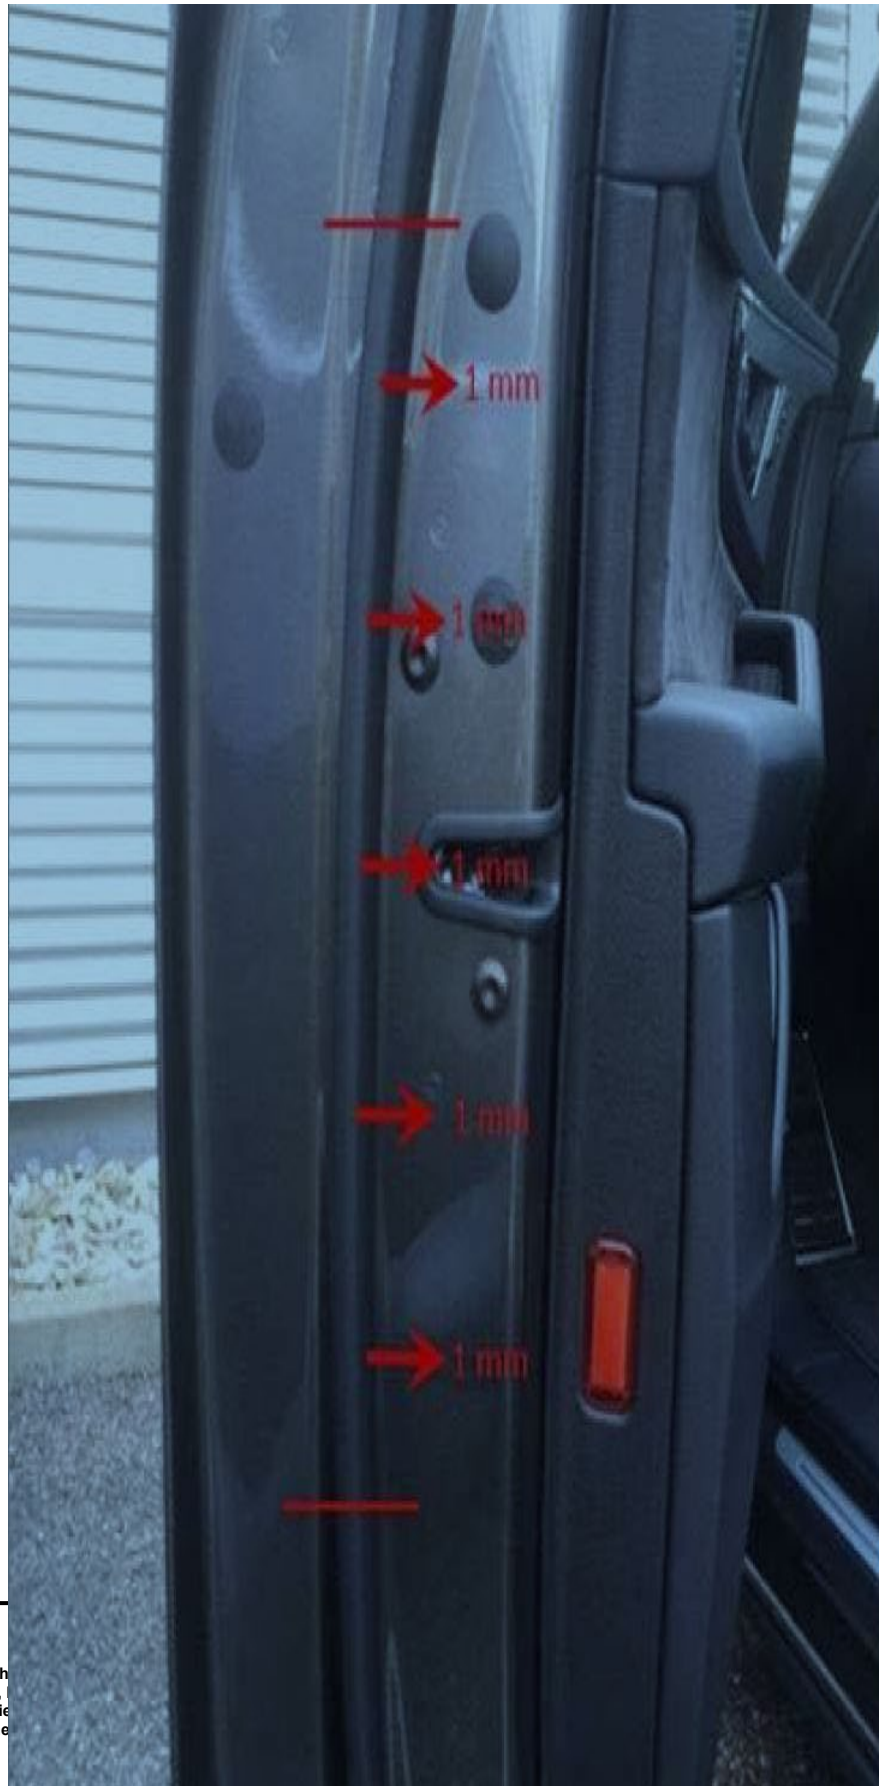
Figure 3. Install the new outer door seal with an inward offset of 1.0 mm.

4. If the customer concern persists, install a new outer door seal with an inward offset of 1.0 mm when compared to the original door seal location (Figure 3).

Tip: Mark the position of the original outer door seal before replacing it.
