# Technical Service Bulletin

## 91 ConBox: Wireless Audi Smartphone Interface (CarPlay / AndroidAuto) inop

91 24 18 2073333/5 June 17, 2024. Supersedes Technical Service Bulletin Group 91 number 24-00 dated April 15, 2024 for reasons listed below.

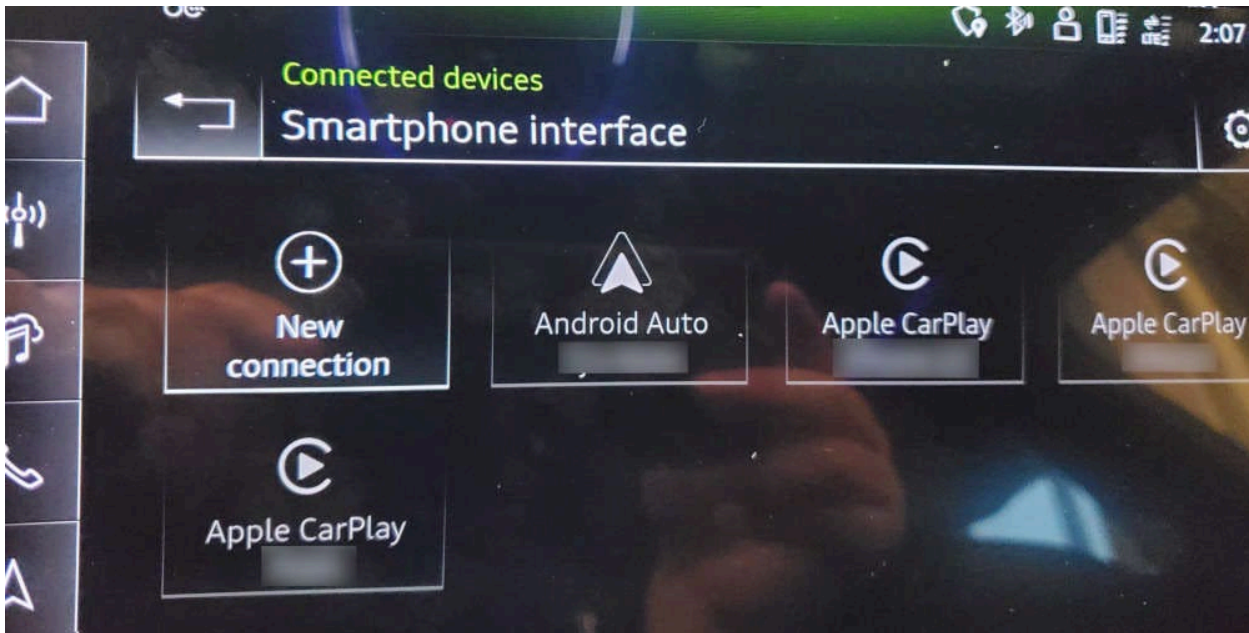
- The Audi Smartphone Interface [ASI] (Apple CarPlay [ACP] / AndroidAuto [AA]) cannot be paired to the phone wirelessly.
- The phone tiles under the ASI menu are grayed out (see Figure 1).

**Figure 1:** wASI connections grayed out.

Due to a configuration issue, the 5GHz Wi-Fi may not be available in some vehicles, preventing wASI from functioning.

1. Please execute the “*Check control module configuration*” test plan under Guided Functions for the Emergency Call Module and Communication Unit (ConBox) -J949- (address word 0075).

2. Delete all Audi Smartphone Interface (ASI) connections from the vehicle.
3. After a bus sleep cycle, the correct functionality should be reestablished.
