# Technical Service Bulletin

## 93 PSS Q8 e-tron: Charging flap module without search illumination; P33E300; B1A8AF3

93 24 61 2073481/3 June 28, 2024. Supersedes Technical Service Bulletin Group 93 number 24-58 dated May 31, 2024 for reasons listed below.

Model(s)	Year	VIN Range	Vehicle-Specific Equipment
Q8 e-tron, Q8 Sportback e-tron, SQ8 e-tron, and SQ8 e-tron Sportback	2024 - 2025	All	Not Applicable

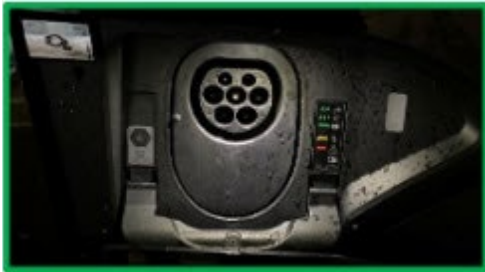
*Figure 1: Vehicle with functioning orientation light in the charging flap module.*

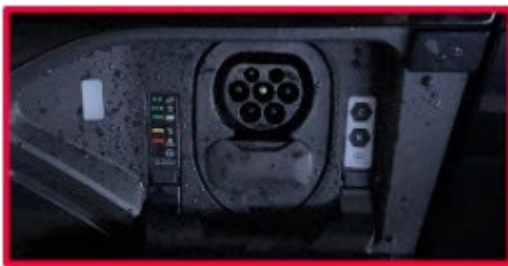
If the vehicle is only equipped with single charging flap module the orientation light does not work. An error in the OBC (00C6) software means that the orientation light LED is not activated when the vehicle is equipped with only one charging flap module.

*Figure 2: Vehicle with a non-functioning orientation light in the charging flap module.*

- Explain to the customer that a solution is expected to be available by the end of the 3<sup>rd</sup> quarter of 2024 (subject to change) and that no repairs are necessary at this point. Do not replace any components for this condition since this will not resolve the customer's concern.
- Create a PSS record in the PSS application through the Pending Service Solutions (PSS) link in AccessAudi (under *Related Links >> Service*).
