# Technical Service Bulletin

**Engine: Cylinder head cover- oil residue Q5 (inline 40cyl., 2.0 ltr. TFSI).**

15 24 50 2072716/3 June 12, 2024. Supersedes Technical Service Bulletin Group 15 number 24-49 dated May 16, 2024 for reasons listed below.

Model(s)	Year	VIN Range	Vehicle-Specific Equipment
Q5	2021 - 2023	All	2.0L TFSI

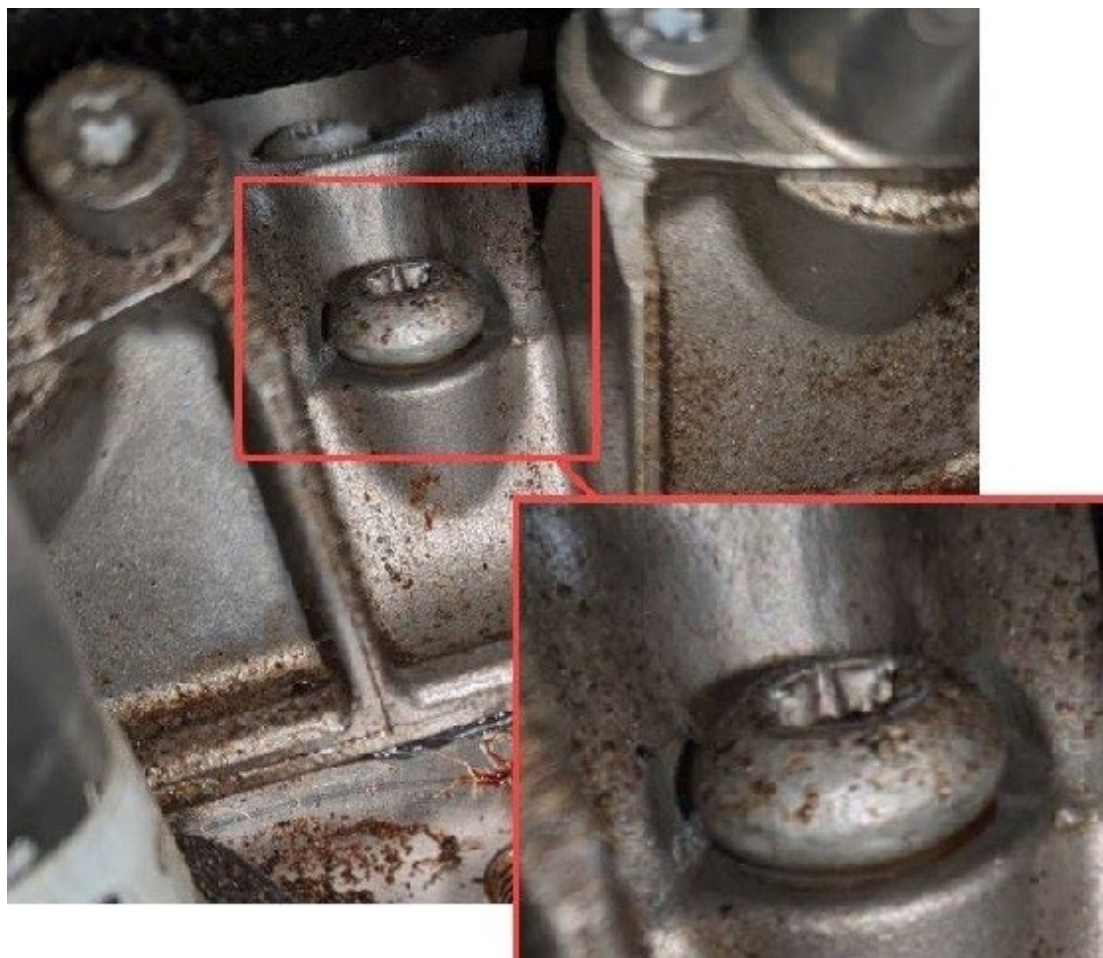
- The cylinder head cover is leaking in the area around the threaded connection on one or multiple bolts (Figure 1).

*Figure 1: Oil on the threaded connection.*

In cases, burrs on the cylinder head cover bolts can cause the bolts to become loose. This can cause oil residue in the area around the threaded connection.

Burrs in the screw are caused in the threading process. Adjustment and verification of the tool for material feeding by screw supplier.

- Please replace the affected bolt(s).

- Please ensure that replacing the bolts remedies the leaking.
