# Technical Service Bulletin

## 53 Creaking or knocking noises from rear of vehicle

53 24 09 2071019/2 June 11, 2024. Supersedes Technical Service Bulletin Group 53 number 23-08 dated July 25, 2023 for reasons listed below.

| Model(s) | Year | VIN Range | Vehicle-Specific Equipment |
|---|---|---|---|
| Q4 e-tron, and<br>Q4 e-tron<br>Sportback | 2022 - 2023 | All | Not Applicable |

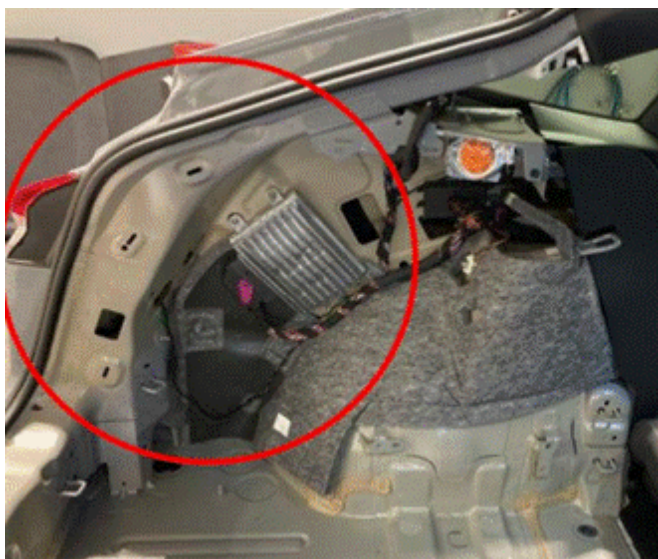
**Workshop findings:** The noises can be replicated in these driving conditions. The noises are diagnosed as originating specifically in the rear cargo area from the sheet metal overlap of the left rear side panel and the left rear cross panel.

**Figure 1.** Area of cargo area where noises are generated.

1. Detach the left rear luggage compartment side trim panel according to the work procedure in Elsa: *Repair manual>>Body>>Body Interior>>70 Interior Trim>>Luggage Compartment Trim Panels>>Luggage Compartment Side Trim Panel, Removing and Installing.*
2. Figure 3 shows the exposed area where the work is to be performed.
3. It will be necessary to drill 3 holes using an 8 mm spot weld drill bit (e.g., VAS6322A/2).
4. Attach the drill bit to a drill motor. Figure 5 shows the spot weld that need to be removed.
5. Figure 6 shows the 3 overlapping panels. For the purposes of illustration, they are numbered 1 through 3 with 1 being the support panel, 2 being the left rear cross panel and 3 being the left rear side panel.

6. Drill the first hole directly into the upper spot weld. Drill the second hole just to the right of the first hole. Drill hole 3 on the other side of the radius of the support panel as shown in figure 7. All 3 of these holes must not penetrate panel 3 (left rear side panel).

7. Grind the area as these 3 holes will now be welded.
8. Grind out the holes with a deburring tool to remove any residual primer from the surfaces to be welded.

9. Push the support panel as close to the overlapping panels comprised of the left rear side panel and the left rear cross panel as possible using a drift. Isolate and protect the surrounding area to prepare for welding.

10. If necessary, perform a test weld to ensure proper settings for an optimum weld application.
11. Weld all 3 holes such that they are completely closed.

12. Prepare and clean the welded surfaces as necessary. Thoroughly restore all corrosion protection appropriately. The corrosion protection will need to be applied using a brush.

13. After the curing time is complete, seal the entire work area with cavity wax (D 308SP5M1 or equivalent e.g. 3M™ 08852) both on the inside and outside. Test drive the vehicle to confirm resolution of the noises. Reinstall the luggage compartment trim.
