Technical Service Bulletin

90 Audi virtual cockpit display has a white sheen

90 24 98 2065932/3 June 3, 2024. Supersedes Technical Service Bulletin Group 90 number 24-77 dated February 6, 2024 for reasons listed below.

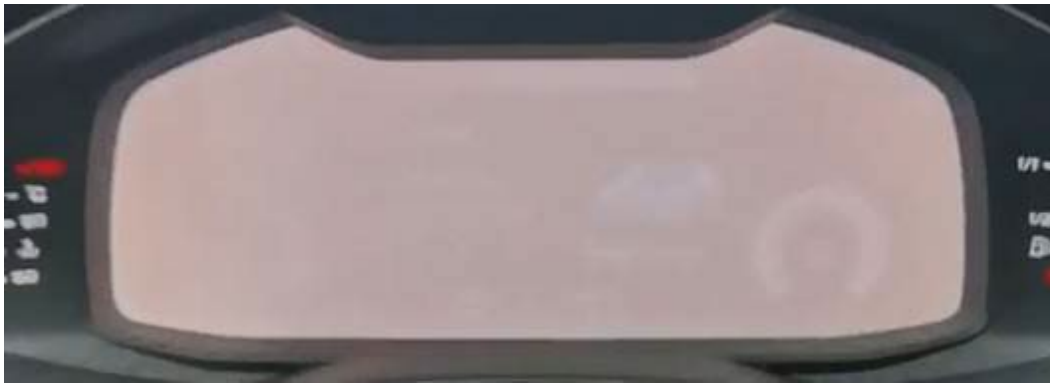
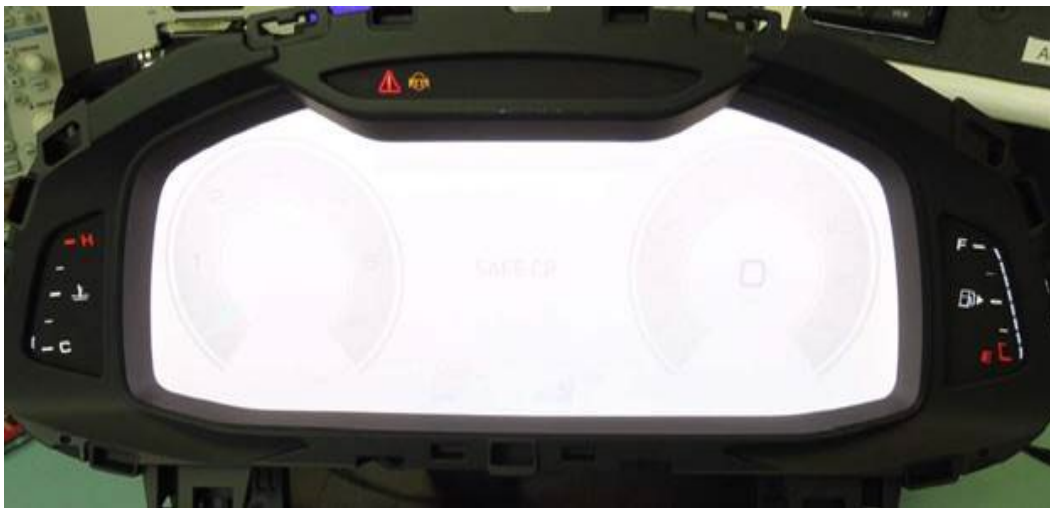
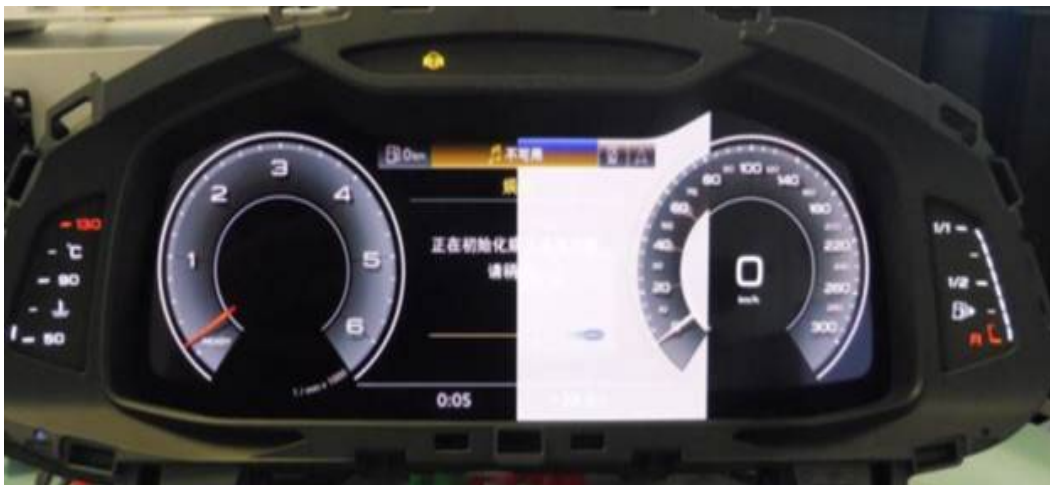
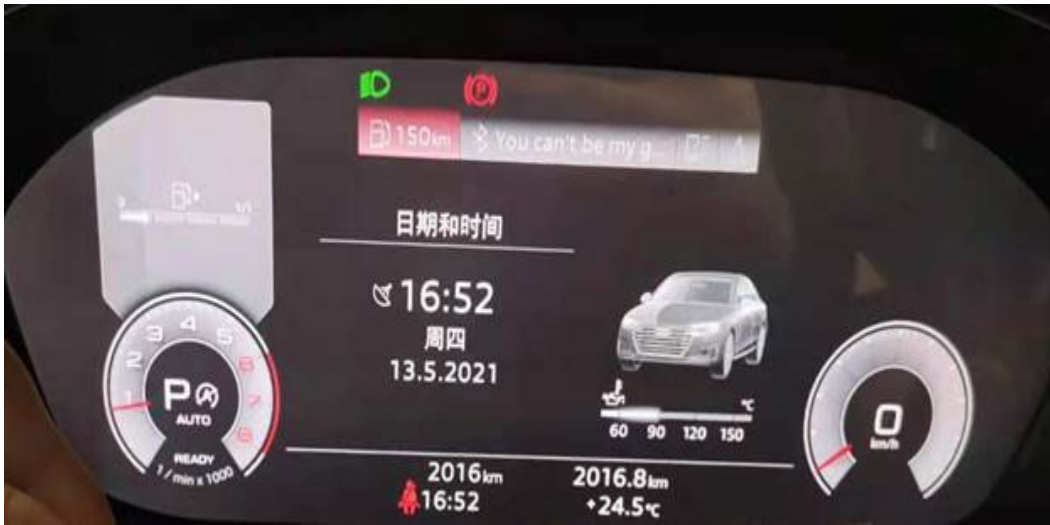
The Audi virtual cockpit has a white sheen over either the complete screen or partial sections.

Figures 1-4. Example pictures of white sheen on the Audi virtual cockpit.

A hardware issue in the Audi virtual cockpit may cause it to have a white sheen. All the display content is still visible and functional through the white sheen.

1. In the warranty claim notes, document the production date of the instrument cluster. To do so:
 - a. Using Self Diagnosis: Select diagnostic address 17.
 - b. Use the control module OBD drop down and select "Identification".
 - c. Click "show expanded identification".
 - d. Expand the "Fazit identification" and document "Day of manufacture".
2. Replace the Audi Virtual Cockpit -J285- according to the instructions of the ELSA repair manual.
