Technical Service Bulletin

90 Audi virtual cockpit: superimposed information on the display

90 24 04 2074291/1 June 26, 2024.

Model(s)	Year	VIN Range	Vehicle-Specific Equipment
e-tron, e-tron Sportback, e-tron GT, and RS e-tron GT	2023 - 2024	All	Virtual Cockpit

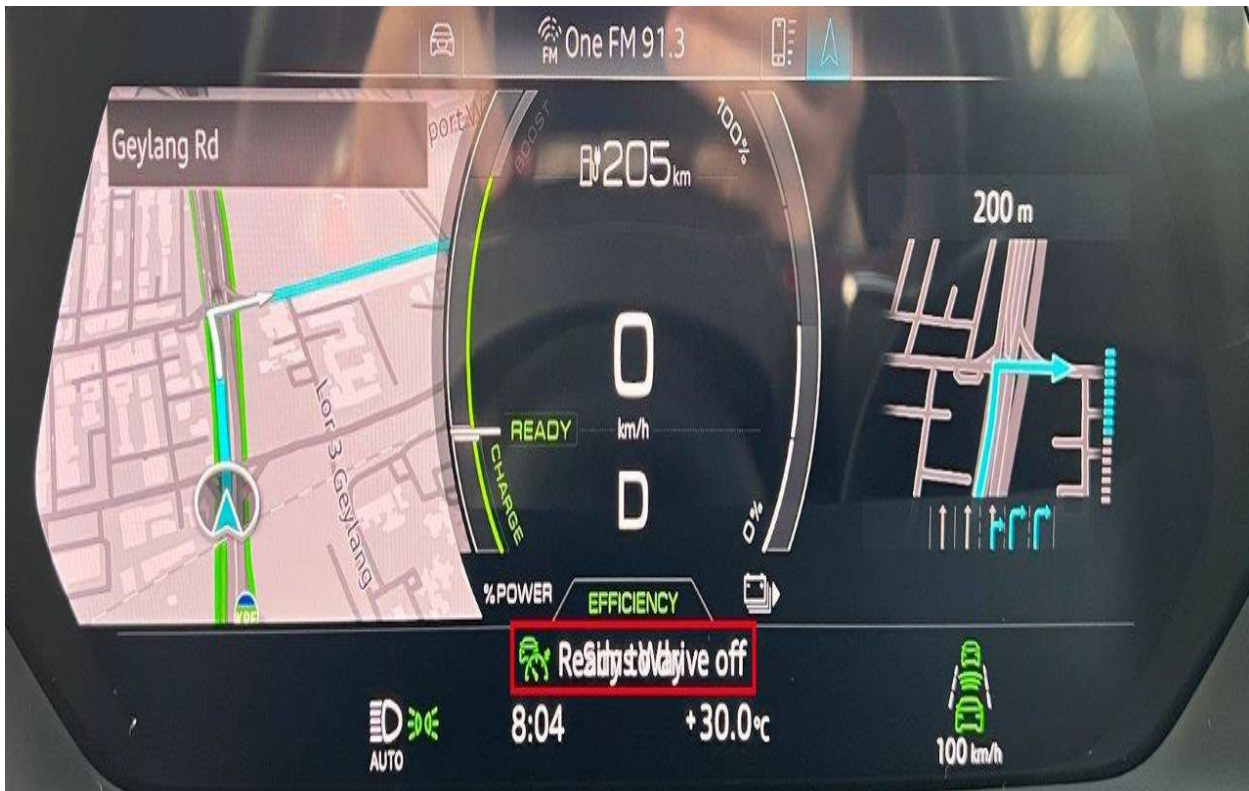
The complaint only occurs in classic performance layout (with the power meter in the center of the display). The concern does not occur in the two other layouts. In Figure 1, the area affected when the issue occurs is marked in red:

Figure 1: Superimposed content inside red square.

Software issue in Audi virtual cockpit.

Download the software from MirrorServer using the SD Creator Program or, if not available for download, order the update medium from parts with the part number listed in *Required Parts and Tools*.

Start the update on the workshop tester by selecting “flash” and entering the specified SVM code. When the following (or similar) appears while you are running the program: “... please insert update medium with the following part number...”, insert the USB stick into a USB port in the vehicle which is suitable for data transmission.
