Technical Service Bulletin

96 Lane change assist: side assist and exit warning system: unavailable. Sensor view restricted (DTC C12AA00)

96 24 99 2073683/2 June 21, 2024. Supersedes Technical Service Bulletin Group 91 number 24-01 dated April 16, 2024 for reasons listed below.

Model(s)	Year	VIN Range	Vehicle-Specific Equipment
RS 6 Avant	2021 - 2025	All	Not Applicable

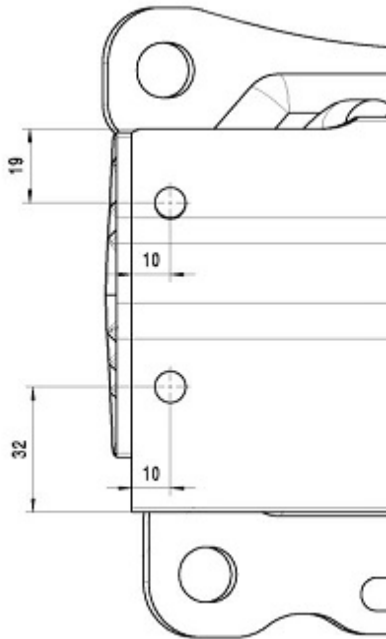
Figure 1: Illustration showing positioning of holes for spreader rivets.

To secure the covers, two holes (8 mm diameter) must be drilled on each side (left and right) of the bumper cover, as shown in the image below:

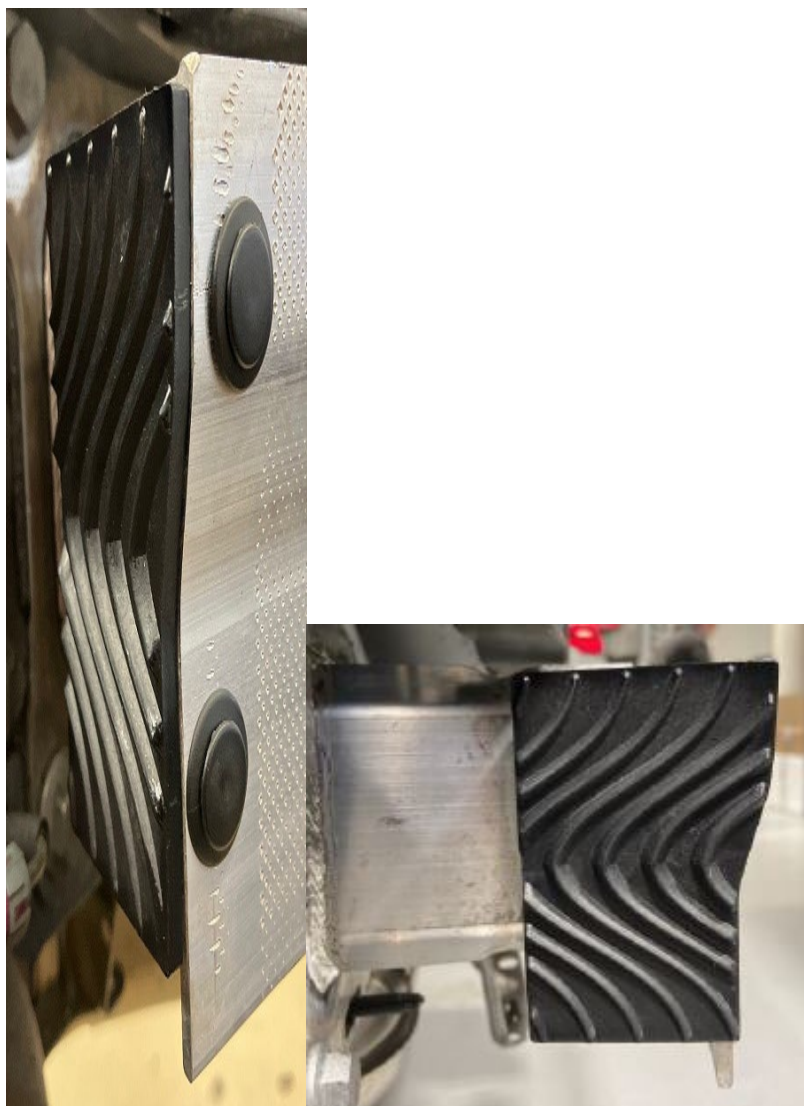
Figure 2: Cover mounted on bumper carrier (left side).

Re Cover the holes and openings on both sides of the bumper carrier. To do so, please use the following covers:
