# Technical Service Bulletin

## 51 Water sloshing sound is heard while driving

51 24 30 2061754/5 June 28, 2024. Supersedes Technical Service Bulletin Group 51 number 24-28 dated February 15, 2024 for reasons listed below.

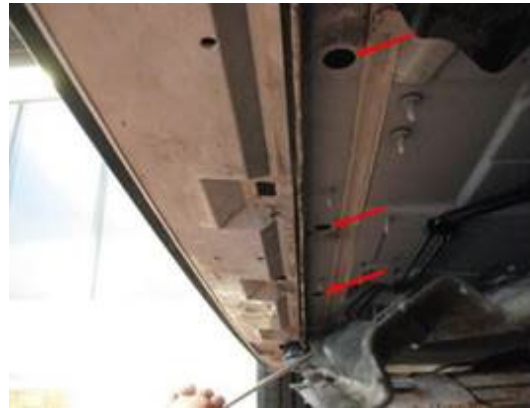
**Figure 1.** Access to the side member plugs.

1. Carefully inspect all mounting points of the sill trim on both sides of the vehicle for any contact inconsistency that would allow water to enter the sill trim. The sill trim must be watertight and be fitted correctly to the body. Also check the drainage of the sill trim. Ensure that water drains away from the sill trim freely.
2. Should collected water be discovered between the sound absorber partitions in the side members, proceed as follows.
3. Detach the underbody trim until the plugs for the side member are accessible. If water has already accumulated in the sill areas water will flow from these plug openings (Figure 1).

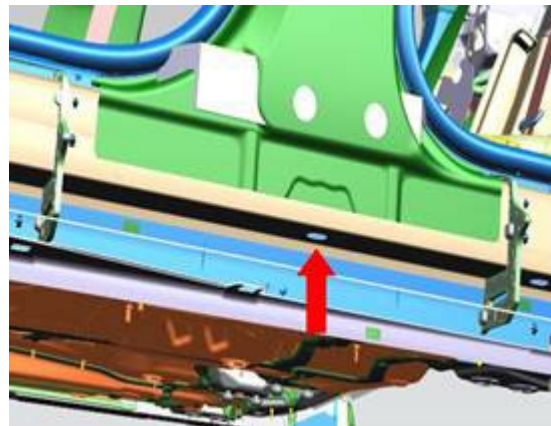
It is possible over time for water to accumulate in the side members and sills, but the water is not able to drain as needed. The accumulated water is unable to reach the normal drainage because the sill cavity sound absorber blocks its flow. This accumulated water creates a 'sloshing' noise when the vehicle moves.

4. Figure 2 shows the opening where water generally enters this space.

**Figure 2.** Water entrance point.

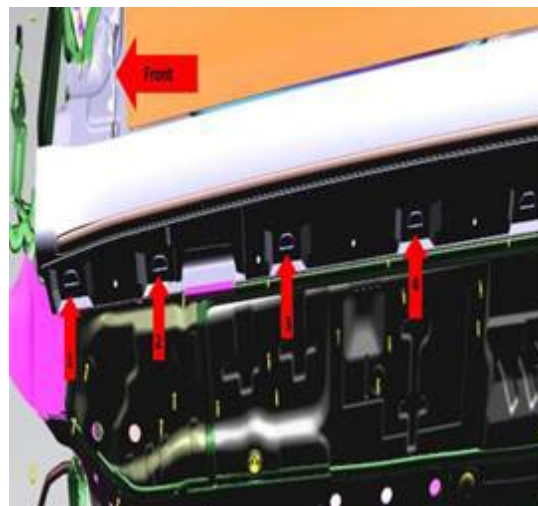
**Figure 3.** Sill trim fastener openings.

5. Fastener position number 4 shown in Figure 3 is the opening through which a modification to the sound absorber will be made.

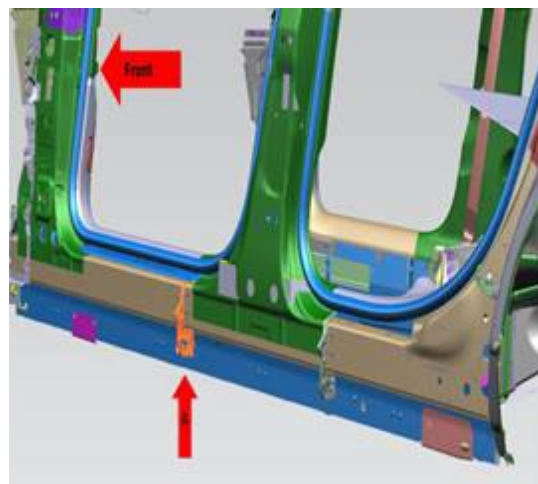
6. Figure 4 shows the location of the sound absorber marked 'A'.

**Figure 4.** Location of the sound absorber.

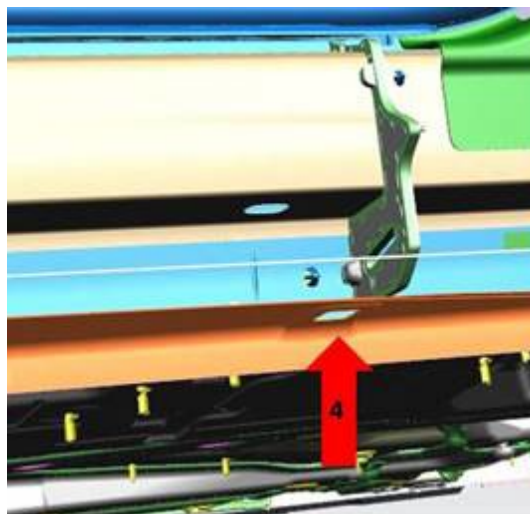
**Figure 5.** Hole through which the sound absorber will be accessed.

7. Figure 5 shows a closer view of the sound absorber to be modified in the cut-away image.

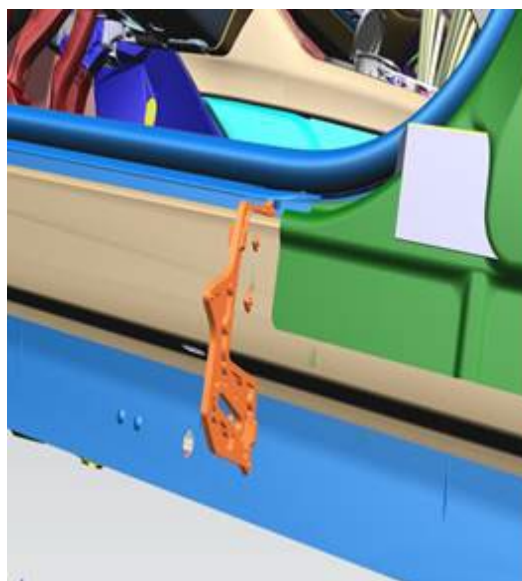
**Figure 6.** Side member cavity sound absorber.

8. Figure 6 shows a cut-away view of the sound absorber from the rear.

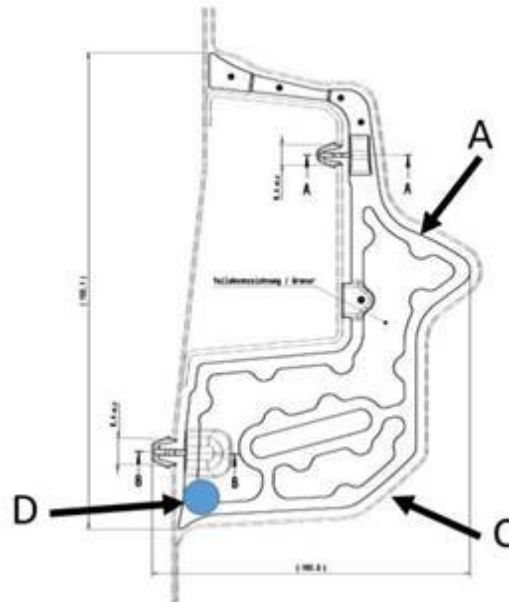
**Figure 7.** 8mm – 10mm hole to be made through the sound absorber.

9. Figure 7 shows a drawing of the sound absorber. The blue dot marked 'D' corresponds with a point through which a hole 8mm – 10mm in diameter will be made. This hole will allow for a normal flow of any accumulated water to reach the normal drainage and exit the sill cavity. The method for creation of this hole follows.

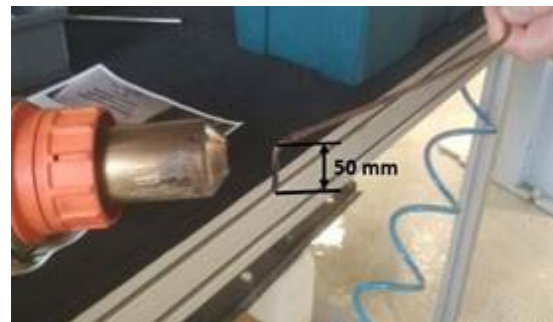
**Figure 8.** Heating the fabricated tool.

10. From a steel rod 8mm – 10mm in diameter fabricate a tool as shown in figure 8. Bend the end of it in an 'L' shape 50mm long. Heat the bent end of the rod to approximately 500 °C (~932° F).

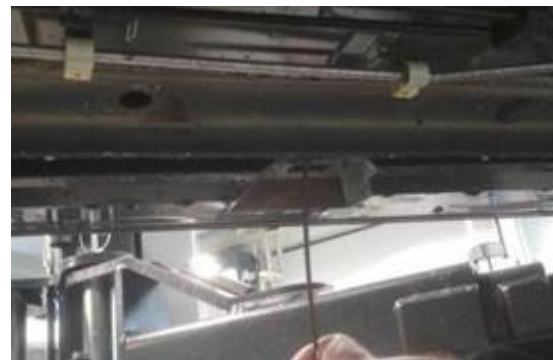
**Figure 9.** Making the hole in the sound absorber.

11. Guide the heated rod into opening number 4 from Figure 3 and melt a hole in the sound absorber in position 'D' from figure 7 (Figure 9).

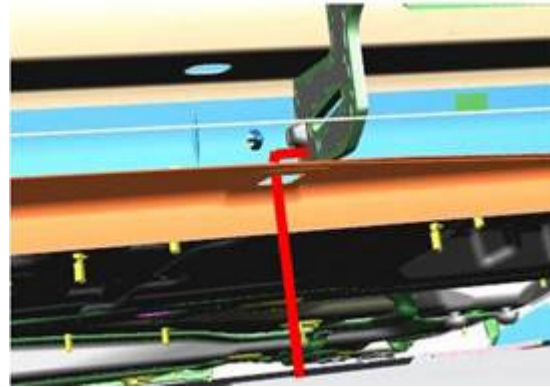
**Figure 10.** Correct positioning of the heated rod.

12. Figure 10 shows a drawing of the operation performed and the correct positioning.

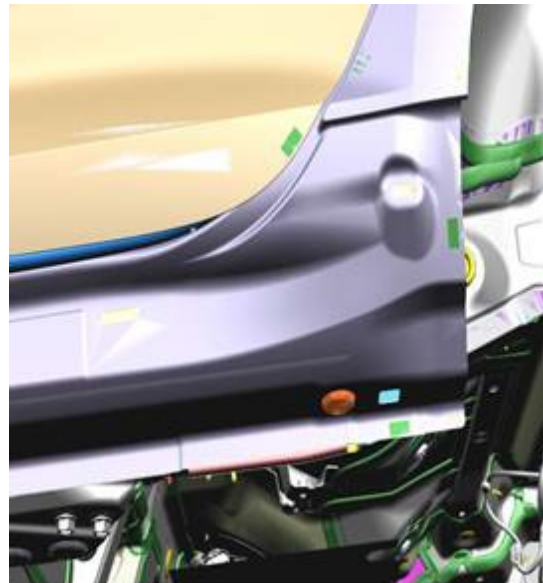
**Figure 11.** Drain plug on rear of the side member.

13. Apply cavity preservative or anti corrosion wax to the area in the cavity having been modified. Use a sprayer VAG 1379, VAG 1538 or equivalent generic sprayer to carry out this operation.
- Ensure that the drain function of the draining plugs on the front and rear of the side members are fully functional and not damaged (Figure 11).

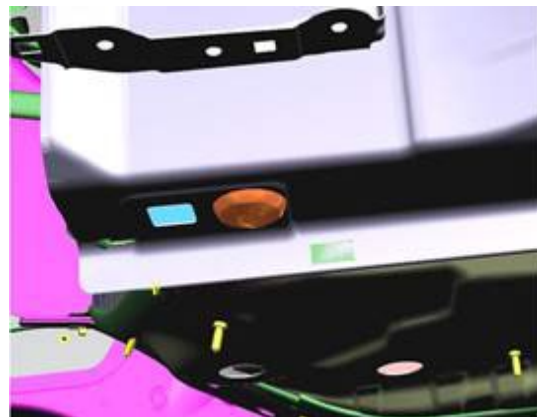
**Figure 12.** Drain plug on the front of the side member.

14. Figure 12 shows the drain plug on the front of the side member.
