Y1A - Homelink® Garage Door Opener Configuration Inoperable

Models	Model Year	Model Type	VIN Range	Vehicle-Specific Equipment
Taycan	As of 2020	Y1A, Y1B, Y1C	N/A	N/A

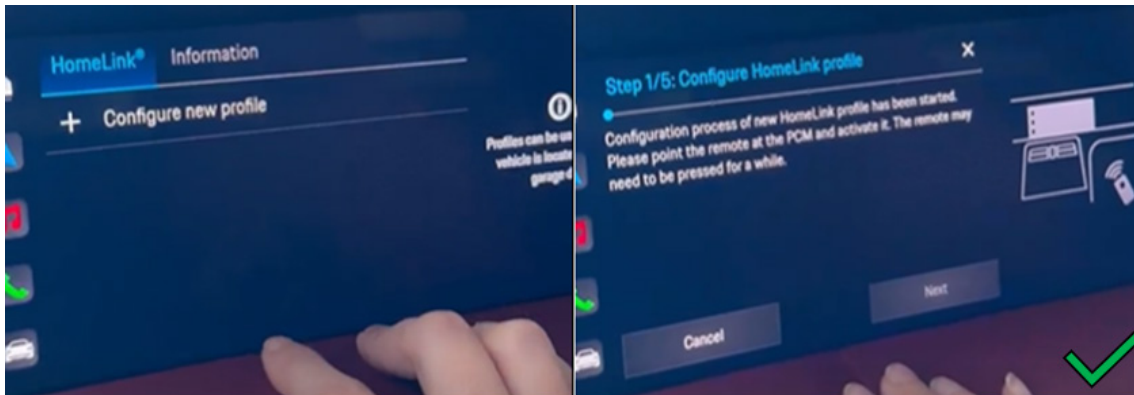
Figure 1 - Correct Programming Procedure

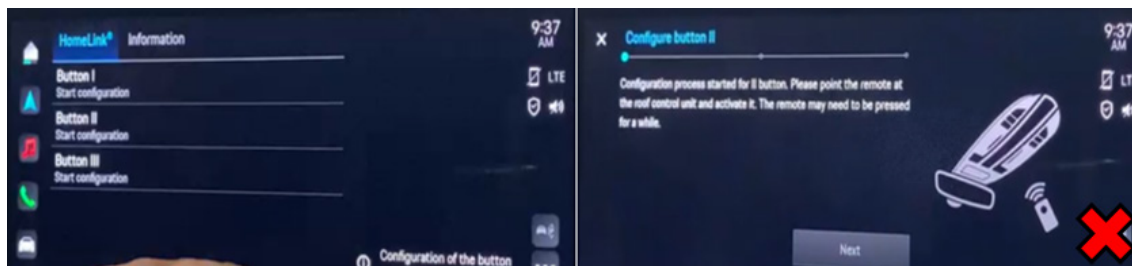
Customer states the Homelink® profiles have been erased and programming process has been changed (doesn't match the vehicle) to no longer be possible. (This ATI applies to the concern shown in Figure 2.)

There is a conflict in the PCM software that has changed the Homelink® GDO programming process to be representative of a different model. There are no fault codes associated with this issue. Refer to the images below for the correct & incorrect programming procedures.

Figure 2 - Incorrect Programming Procedure

Create a PCSS job for the concern and attach pictures of the Homelink® profiles and programming procedure screens. Follow the listed conditions below for the PCSS job:

This topic is currently under investigation. No parts are to be replaced at this time.

This ATI will be updated when a software solution is released.
