APB5 - Replacing the Cell Block Module on High-Voltage Battery (Recall Campaign)

Vehicle Type: **Taycan (Y1A / Y1B / Y1C)**

Concerns: **Cell block module**

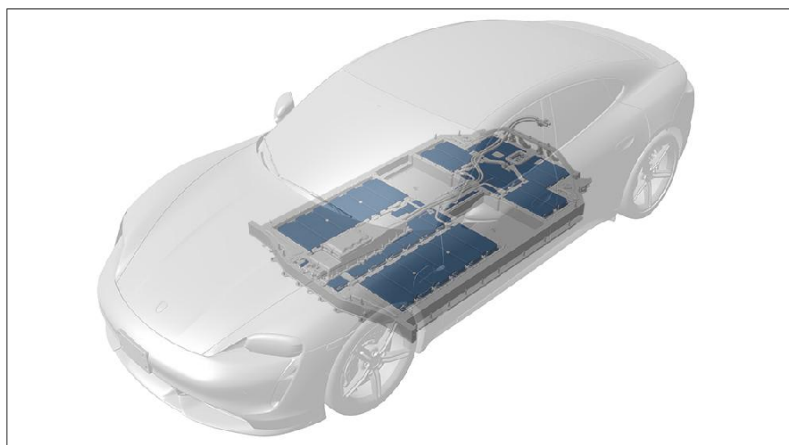
Installation position: Cell block module

Cause: **There is a possibility that, under certain circumstances, a defect in the battery cells installed in the high-voltage battery can occur on the affected vehicles.**

In this case, a short circuit within the battery modules during the vehicle's service life cannot be ruled out, which could lead to thermal events and later to a fire in the vehicle.

Action: Replace cell block module.
