Panamera E-Hybrid - "Remove Charger Plug" Message in Instrument Cluster

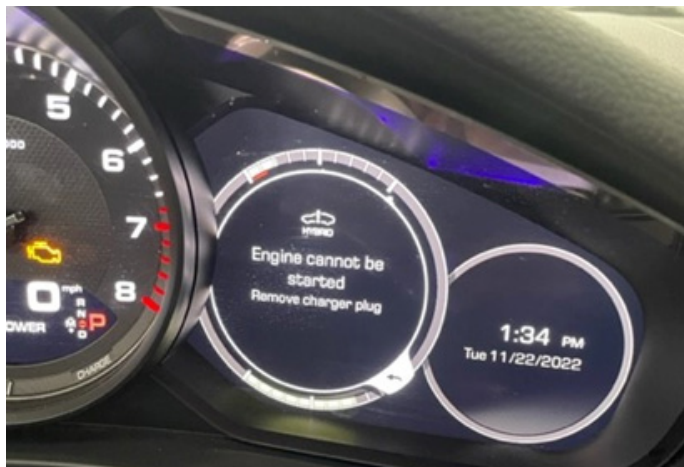
Figure 1

Following a software update or installation of a replacement 3.6 kW On-Board Charger (OBC), the workshop finds a white hybrid warning in instrument cluster as shown below. This message occurs on start-up even when no HV charging plug is connected. The following fault is present in the Instrument Cluster control unit:

B19DAF0 - Display of charger plugged in, no engine start, active
Fault **EA6639**.

This condition is due to a known software error in newly produced replacement 3.6 kW Onboard charger (OBC) parts with software level 6021. The issue has been investigated by PAG and the supplier and a root cause was identified in production.

Replacement parts are now available to correct this condition. They are designated with the same part number as before (PN PAB915682B). If a vehicle arrives and diagnosis leads to need of an exchange OBC or the aforementioned symptom of faulty charger plug detection, then it is recommended to order an additional OBC part from the PDC according to standard procedures.
