Rear Door Symptom: Creaking Noises at the Rear Door when Opening or Locking (SY 80/24)

Model Line: **Taycan (Y1A / Y1B / Y1C)**

Model Year: **As of 2020**

Concerns: **Rear door**

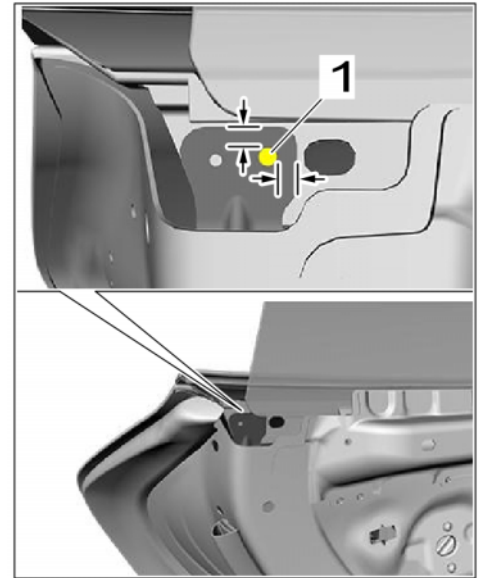
Rework rear doors

Cause: **Customers complained about creaking noises when opening and locking the rear left and/or rear right door.**

Relative movements between the shaft reinforcement and the lock reinforcement within the door frame may cause intermittent creaking noises.

- 6 Rework rear door affected.
- 6.1 Adjust position for an additional rivet on the door reinforcement and set ⇒ *Rework rear doors -1-* marking.
To ensure sufficient stability, ensure that sufficient distance is maintained from the outside areas of the reinforcement. ⇒ *Rework rear doors*
- 6.2 Mark the position of the hole with a suitable center punch.
- 6.3 Equip a suitable drill with a 4 mm drill bit and set the depth stop to a drilling depth of 6 mm to prevent damage to the outer skin of the door.
- 6.4 Drill a 4 mm hole for the rivet in the reinforcement door, with the help of a second person, and vacuum up the chips produced during the drilling process with a suitable wet/dry vacuum cleaner.
Make sure that the rear door window is not damaged during drilling.
