All Vehicles Equipped with M139: CEL for P012800 - The coolant temperature is below the coolant thermostat specified temperature.

| Topic number | LI20.10-P-076206 |
| Function group | 20.10 - Coolant pump, coolant thermostat |
| Validity | All vehicles with any version of M139 engine |

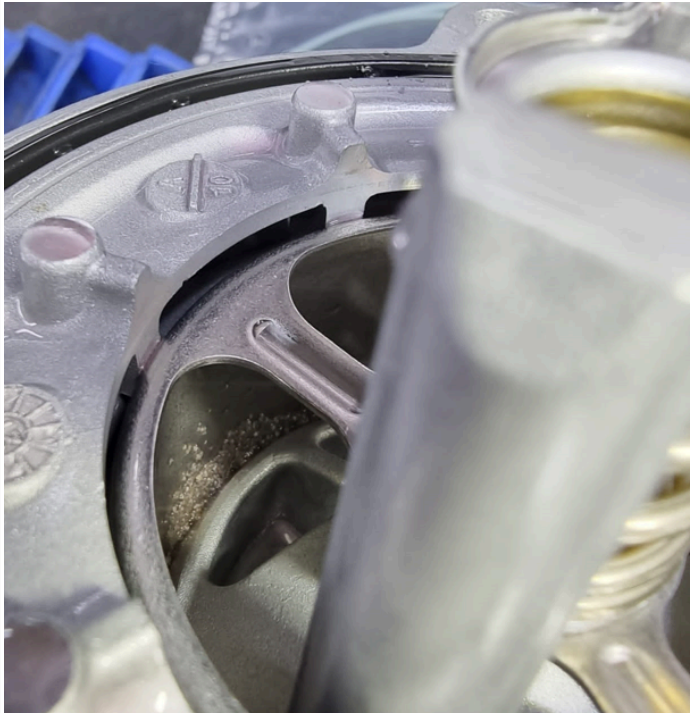
| Attachments | |
|---|---|
| <a href="#">Debris Aft of Sealing Surface of Thermostat.png</a> | |

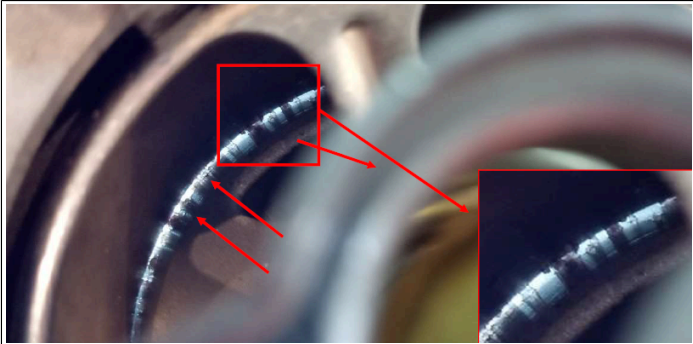
| Attachments | |
|---|---|
| <a href="#">Result of Using Light Source to Detect Debris.png</a> | |

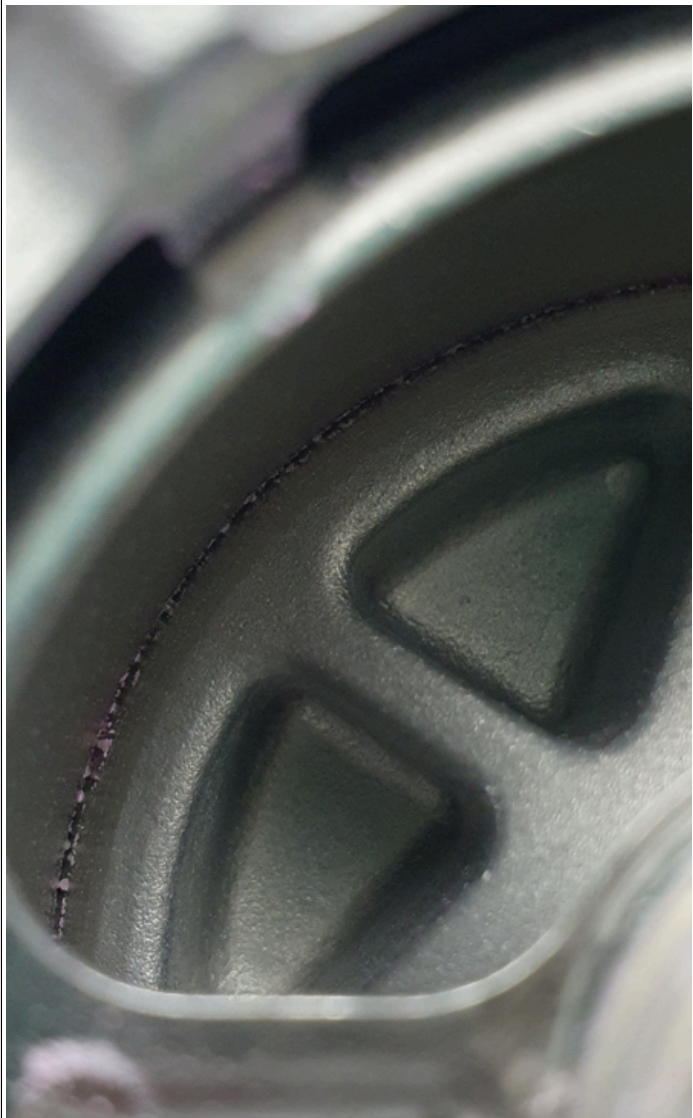
Debris at Interior Sealing Surface of Thermostat.png

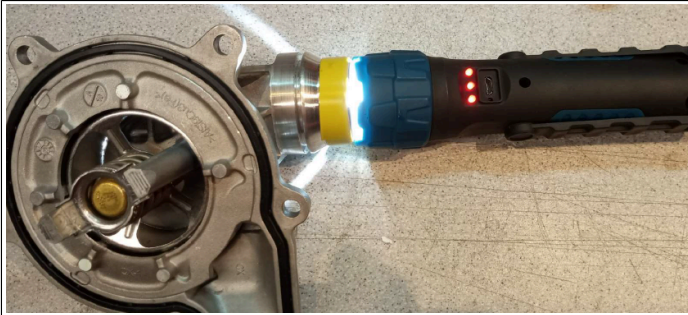
Using Light Source to Detect Debris.png

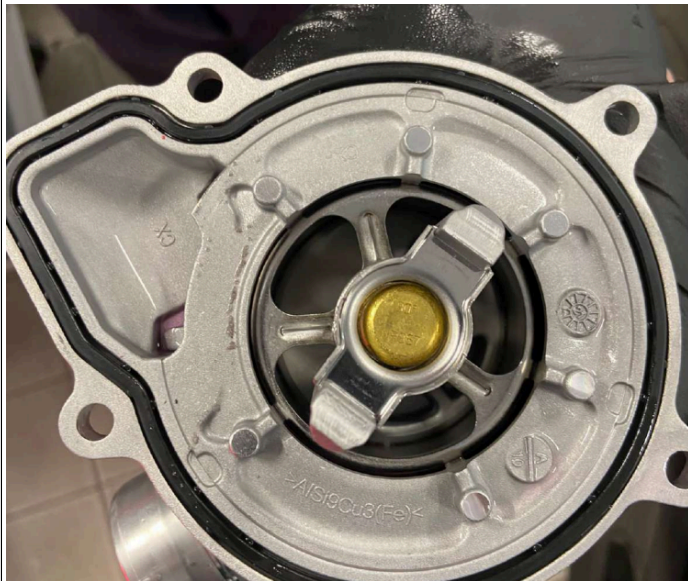
Debris near Mating Surface of Thermostat.png

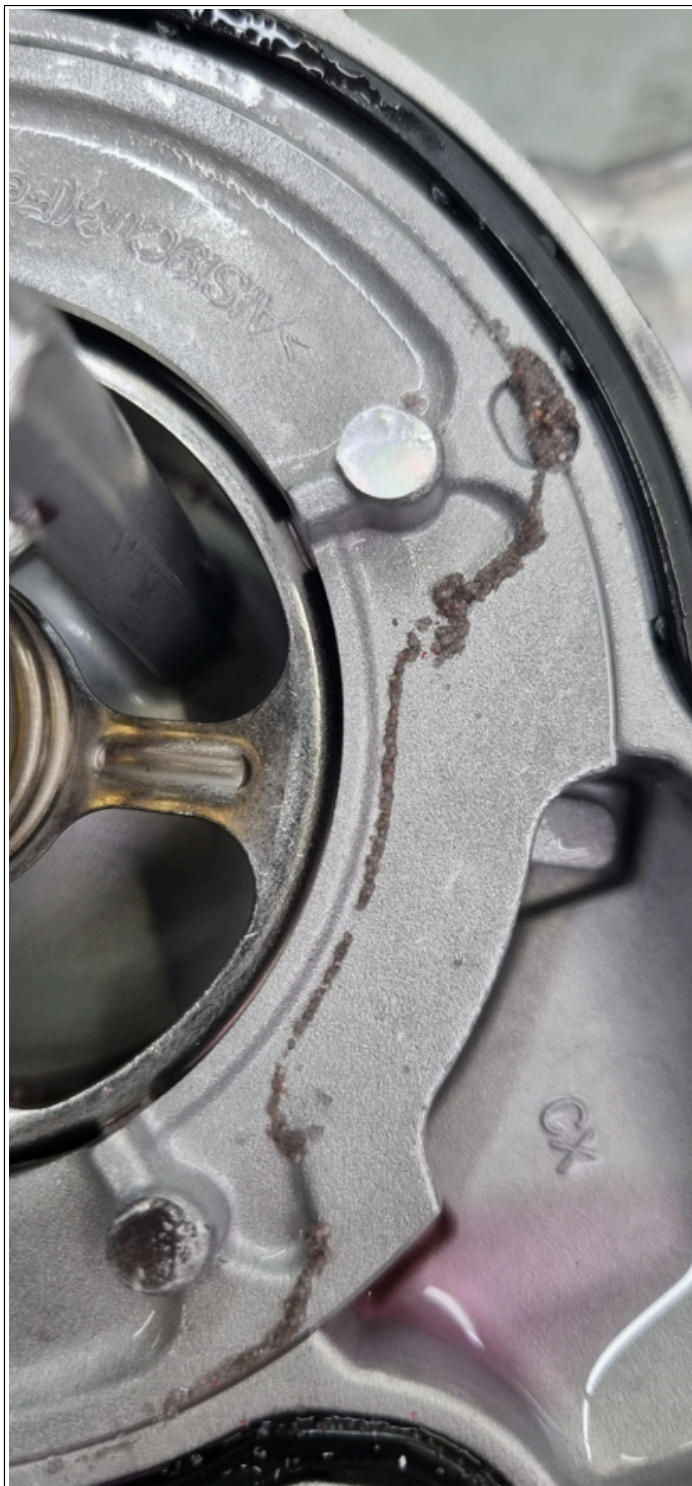
Heavy Debris in Thermostat.png
