REFERENCE:	TSB: 08-129-24 REV. A GROUP: 08 - Electrical	Date:	June 21, 2024	REVISION:	08-129-24
VEHICLES AFFECTED:	2023 - 2025 (B1) Jeep Renegade This bulletin applies to vehicles built on or after December 10, 2023 (MDH 1210XX) and on or before January 24, 2024 (MDH 0124XX) equipped with a Uconnect 5 Nav W 8.4" Disp (Sales Code UPL).		MARKET APPLICABILITY: <input type="checkbox"/> NA <input type="checkbox"/> MEA <input checked="" type="checkbox"/> SA <input type="checkbox"/> IAP <input type="checkbox"/> EE <input type="checkbox"/> CH		
CUSTOMER SYMPTOM:	Customers may comment on the following: <ul style="list-style-type: none"> "Nenhum mapa disponível" message displayed on the multimedia screen. 				
CAUSE:	Multimedia does not have embedded map

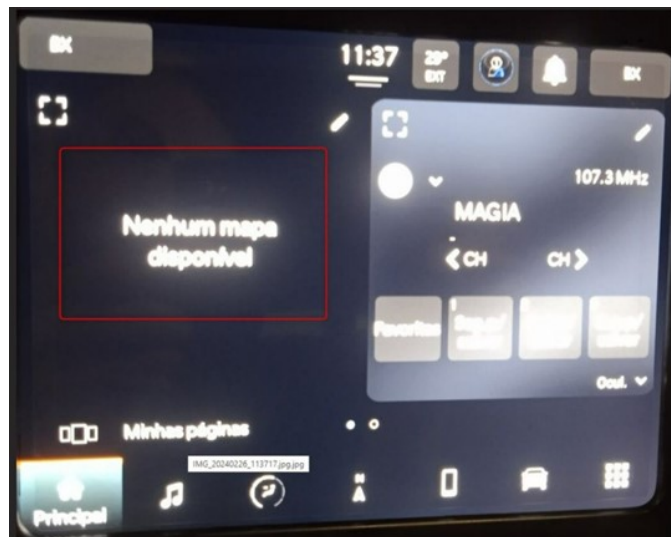
Fig. 1

1. Cycle the ignition to the On position and inspect the multimedia screen for the following message "Nenhum mapa disponível" [Fig. 1](#).

Nenhum Mapa Disponível Message

2. Is the message "Nenhum mapa disponível" [Fig. 1](#) present on the multimedia screen?
 - YES >>> Proceed to [Step 3](#).
 - NO >>> This bulletin has been completed. Use Inspect LOP (08-60-02-9M) to close this active RSU.
3. Replace the radio. Refer to the detailed service procedures available in DealerCONNECT/Service Library under: 5570T80 - Radio - Remoção/Recolocação.
