| <b>Re: Service Campaign</b><br><b>Notification Model: Sprinter (907)</b><br><b>Model Years: 2023</b><br><b>Replace Rear Transmission Mount</b> | DATE: June, 2024 |

| Campaign No. : | Campaign Desc. : | Replace Rear Transmission Mount |
| 2024060006 | VS3VERGET | |
| This is to notify you of a Service Campaign to Replace the Rear Transmission Mount on approximately 76 MY 2023 Sprinter Vans.<br>All affected VINs will be flagged as "OPEN" in VMI. | | |

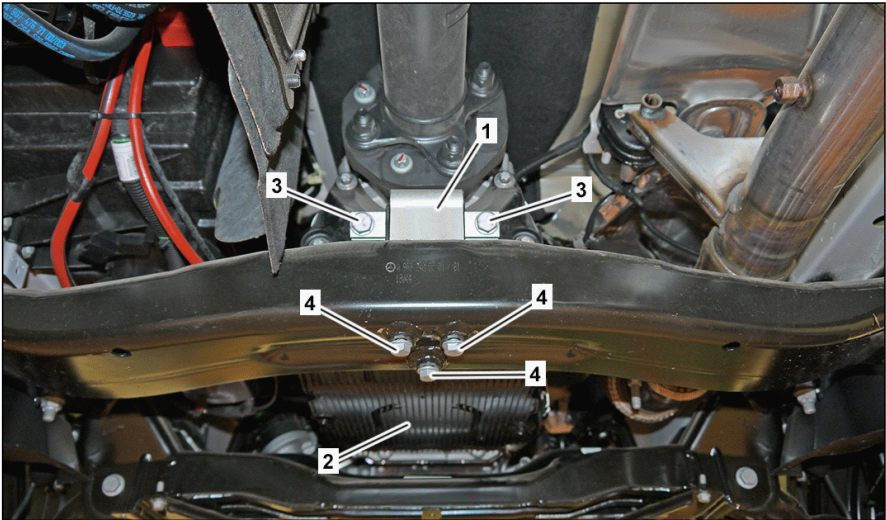
D22.10-A018-75

| Issue | MBAG has determined that the rear transmission mount was not installed per production specifications. | |

Shown with transmission 725.0 except code A4M (4MATIC)

- 1 Transmission mount
- 2 Transmission
- 3 Screw
- 4 Screw

| 3<br> <b>WS</b><br> <b>WS</b> | Support transmission (2) at center.<br>000 588 24 62 00 Major assembly mount<br>000 588 23 62 00 Mounting plate | | WS01.00-P-0253B<br>WS26.00-P-0415B |
| 4 | Remove screw/bolts (3). | <b>Installation:</b><br>Replace screw/bolts (3).<br> Screw/bolt, rear engine mount to transmission | BA22.10-Z-1001-01TSR |

| 5 | Unscrew screws (4).<br><b>Notice</b> Notes on threaded connections fastened using a tightening angle-based tightening process | <b>i</b> <b>Installation:</b><br>Replace screws (4).<br>First attach bolts (4), then tighten together with bolts (3).<br><b>Nm</b> Bolt, rear engine mount to rear engine support | AH00.00-P-0020-01A<br><br>BA22.10-Z-1003-01TSR |
| 6 | Remove and replace transmission mount (1). | | |
| 7 | Install in the reverse order. | | |
