Technical product information

Topic	DTC P0B2500 logged within address 0021 (Battery Energy Control Module 2) - Dynamic ride system warning visible
Market area	Bentley: worldwide (2WBE)
Brand	Bentley
Transaction No.	2068946/7
Level	EH
Status	Approval
Release date

DTC P0B2500 logged within address 0021 (Battery Energy Control Module 2) - Dynamic ride system warning visible

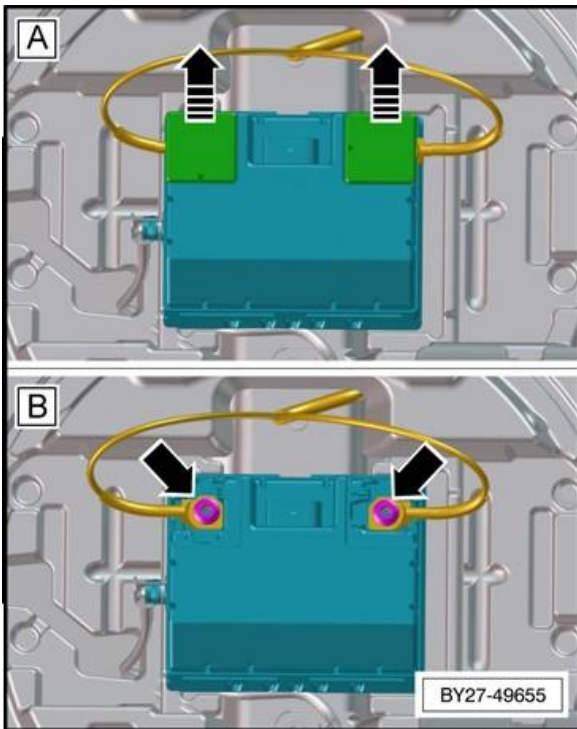
Figure 1

Possible internal fault with the super capacitor

- 1) Referring to Rep.Gr 27 - Deactivate the 48 volt system - Refer to 48 volt system - To activate and deactivate
- 2) Referring to Rep.Gr 27 - Check the security of the super capacitor positive and negative terminals (Figure 1) as follows:
 - Remove the caps (A) from the terminals
 - Check the security of the positive and negative terminals (B) are as described within Rep.Gr 27
 - In the event that one or both terminals were not tightened to the correct torque as Rep.Gr27, the operative must tighten the terminal(s) to the correct torque as detailed within Rep.Gr 27 - Super capacitor

In the event one or both terminals required tightening to the correct torque (found to be not initially secure) the operative must feedback the findings via DISS
