In the instrument cluster, the symbol for "12 V battery" and the message "Switch on vehicle" sporadically appears

Topic number	LI54.10-P-076820
Version	7
Function group	54.10 - Battery, power supply, voltage converter
Date	6/10/24
Validity	MODEL 206 up to production 12/15/23 MODEL 254 up to production 12/15/23
Reason for change	Remedy update

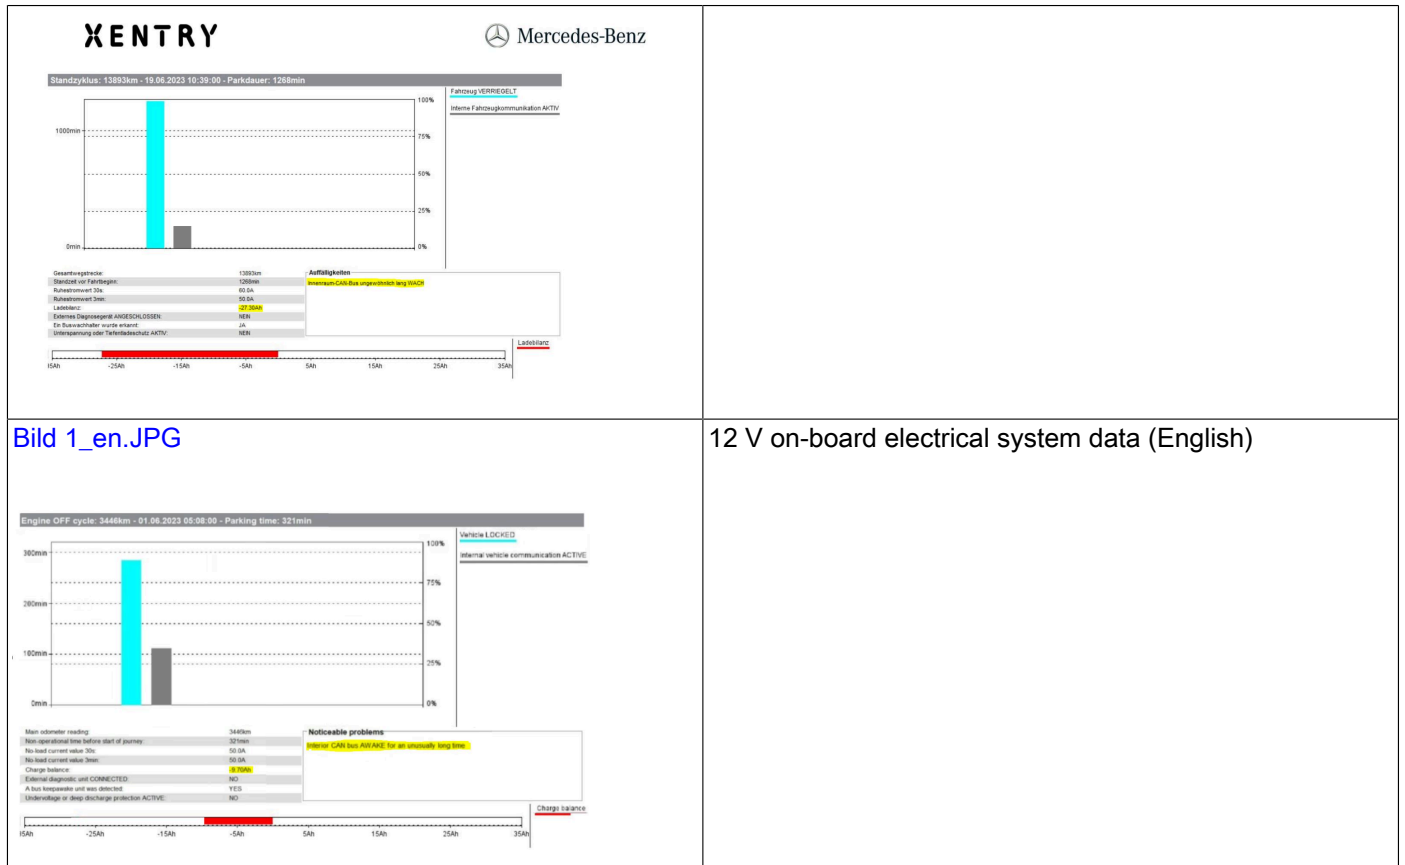
Bild 1_en.JPG

In the subsequent analysis of the 12 V on-board electrical system data, the following parameters are noteworthy (see picture 1 in the attachment):

- Charge balance negative when stationary.
- Interior CAN bus is awake for an unusually long time while the vehicle was locked.
- 12 V battery SOC (state of charge) during subsequent engine start is 45% or less.

12 V on-board electrical system data (English)

The door control unit (N69/x) may sporadically keep the interior CAN bus awake.

Update the software and coding on all 4 door control units (N69/1, N69/2, N69/3 and N69/4):

- To do so, a commissioning process must be started in the door control unit, left-hand front door (N69/1). The remaining door control units (N69/2, N69/3 and N69/4) are commissioned at the same time, in an automated process. (Path: Xentry Scope; Control Units View; TSG-XX (N69/1); Adaptations; Commissioning)
- The repair software has been available since 02.02.2024 and the new SCN coding since 04.06.2024.
- The measures are only 100% effective if the combination of "Repair software + new SCN coding" is used.
