Subject: A-PILLAR TRIM HIDDEN FELT PAD IS VISIBLE	Bulletin No.: 09-031/24
	Last Issued : 06/10/2024

2023 CX-50 (US/Canada spec vehicles with VINS lower than 7MMVA*****107824 (produced before June 15, 2022)

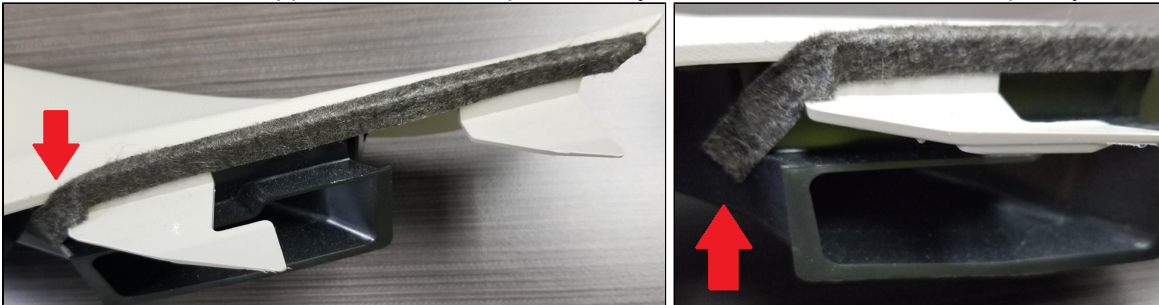
NOTE: The front is wrapped and locked in place. If any of it breaks off, remove it completely.

1. Verify the customer concern.
2. Remove the A-pillar trim on both sides of the vehicle according to the instruction on MGSS ([A-PILLAR TRIM REMOVAL/INSTALLATION](#)).
3. Remove the old felt tape from both A-pillar trim pieces.
