# WARRANTY BULLETIN QUALITY

Campaign no.: 2024-0007

June 12, 2024 Subject: **Rear Suspension Arm Lever Bracket Holes Not Aligned**

No. **2024-7**

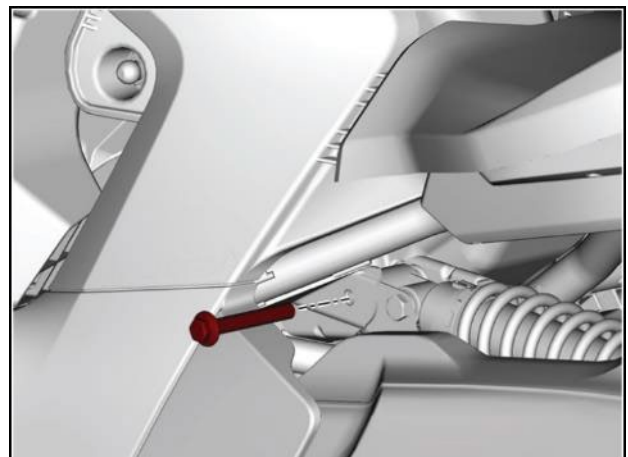
An incorrectly welded bracket to mount the rear pivot arm to the frame may prevent the correct installation of the suspension arm lever front bolt (M12 x 85 hexagonal flanged bolt).

Install a new suspension arm axle.
