RYKER YAW Rate - SAS Sensor Faults - 137209

YAW rate sensor faults might be triggered due to loose front suspension components.

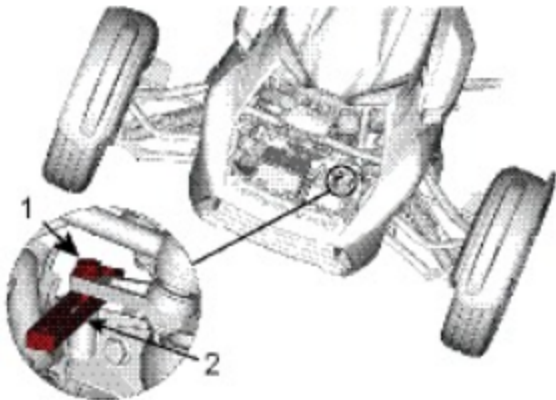
1. Alignment screw
2. Steering column spacer

- Check the wheel alignment with the BRP laser tools. The alignment procedure is attached below as a PDF.
- ALIGNMENT TOOL 529 036 475
- ALIGNMENT ADAPTOR C RYKER REAR WHEELS 529 036 483
- ALIGNMENT ADAPTOR B RYKER FRONT WHEELS x 2 529 036 482
- Important to reset with BUDS2 the SAS/YAW sensor with the steering lock tool once the alignment is done. Simply lock the steering system on the LH pitman arm. Use Alignment screw (P/N 529 036 490)

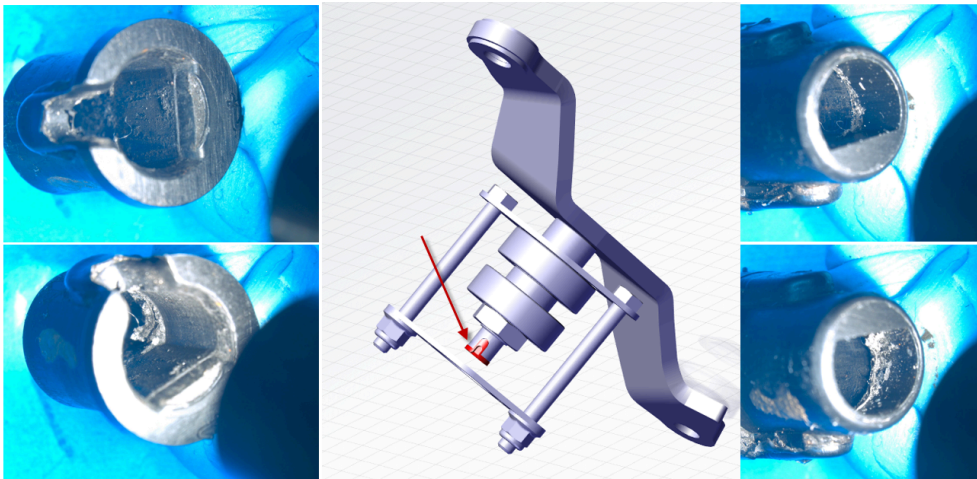
- A good sign that the steering components are too loose is that the SAS plastic bushing will be worn out by the excess of axial movements. The bushing is a tight fit on the SAS shaft. It needs to be replaced if you can easily remove it with your fingers. Here are some examples;
